## Case Study 2: ALL-TEST Pro 5 and ALL-TEST Pro OL

Condition: 2500 HP, 4160 Volt motor showed insulation problems indicating possible winding cure problems or contaminated insulating varnish.

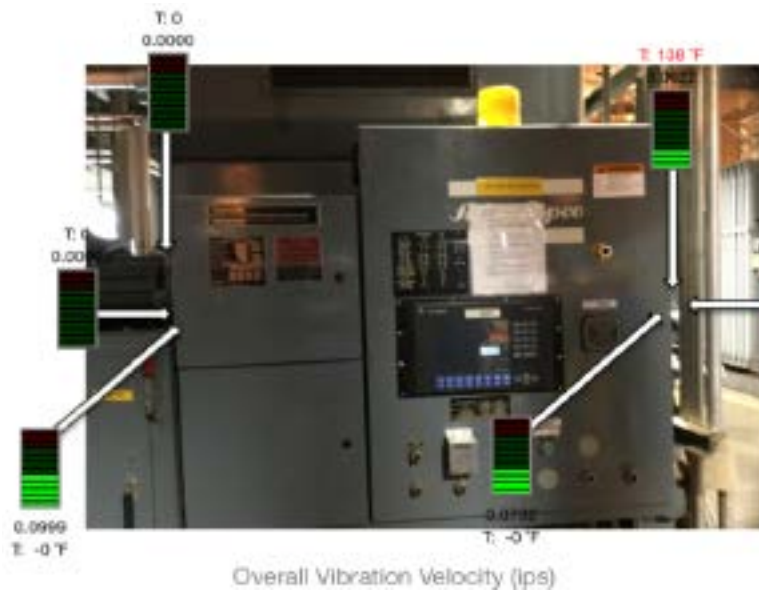
Figure 1: 2500 hp Atlas Copco Motor

The machine was tested with a combination of the ALL-TEST Pro 5 and the data compared to two other similar machines. It had been rewound and had exhibited poor operating conditions including nuisance tripping.

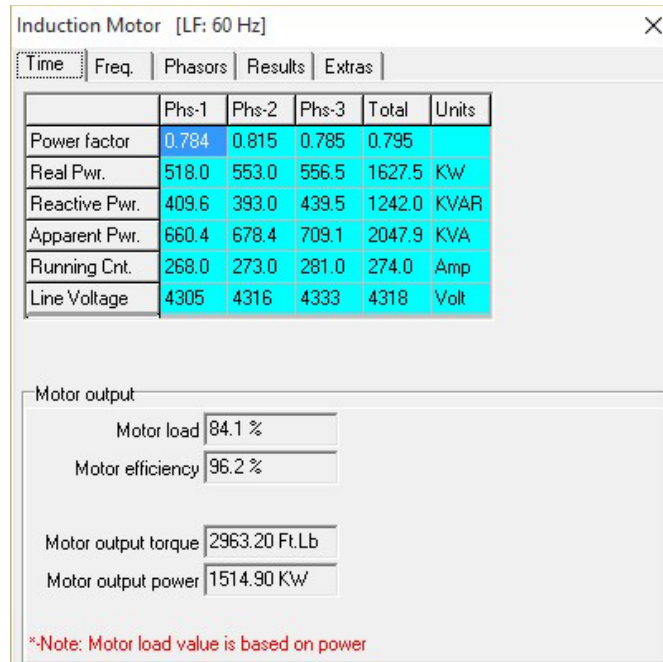
Figure 3: MTR1 Information at 84% load

In the case of Mtr1 (Figure 3) 0.795 PF at 84% load is lower than MTR2 at 0.891 at 110% load and 0.866 at 84.8% load. This would also indicate a core related problem on Mtr1.

The result of the study indicates a problem with the stator insulation in Mtr1, most likely poor varnishing, curing or contaminated varnish. The poor power factor on Mtr1 and lower inductance all relate to increased core losses in the electric machine. This was confirmed with a notation that the motor core temperature is generally 10C hotter than the motor at 110% load. This would relate to excessive stripping temperatures during the repair process causing damage to the core.
