Electrical signature analysis of electric motor driven pumps

by Howard W Penrose, President, MotorDoc LLC

Electrical signature analysis is a powerful tool when diagnosing motor issues in poorly performing pumps. Here, Howard W Penrose presents a case study example, highlighting the performance of two pumps and the insights electrical signature analysis is able to provide into their performance.

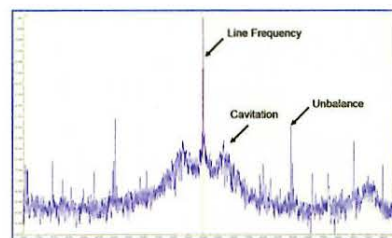
As noted in Figure 1, there is a raised noise floor about the impeller signature which allows the analyst to determine the running speed of the motor. Once the analyst has the running speed and has access to information on other components any potential problem can be identified.

The reason for the raised noise floor is that cavitation relates directly to the significant energy that occurs as gases in the fluid being pumped come into contact with surfaces such as the impeller and collapse, putting off significant energy. This represents enough energy to remove small amounts of material from these

Figure 1. Cavitation signature in low frequency current FFT.

components as well as damage seal surfaces. As these 'explosions' are random, they result in a very random vibration pattern that are related to the impeller. As noted in Figure 1, the raised noise floor is occurring on either side of the line frequency peak at about 5Hz.

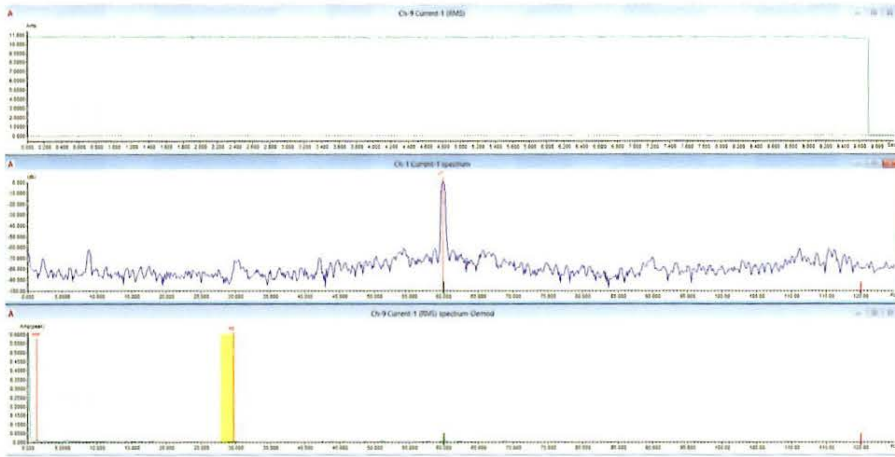
Figure 2. Good low frequency ESA results plus seal issue.

When taking data and a known good machine is available, it provides the ability to compare it to other machines. In this case, the two unloaded 30 horsepower submersibles are readily compared in order to contrast a good and bad machine. In Figure 2, the complete low frequency spectra can be analysed to evaluate conditions related to the motor shaft and impeller.

In Figure 2, the top spectra is the RMS current of the pump in question, the middle spectra represents the frequencies immediately surrounding the line frequency, which is the highest peak, and the bottom spectra is the demodulated low frequency spectra. The RMS current represented here indicates that the machine is running smoothly without too many variations

and is turned off at the end of the analysis. The peak to the far left and noise to the far right in the +/- 45-55Hz range on either side of the 60Hz line frequency, which would be +/- 35-45Hz in a 50Hz environment, is a seal frequency. An existing peak in this range normally means some seal wear, in a mechanical seal. If these peak continue to rise, it normally indicates failing seal surfaces. The remainder are all under -65dB from the peak current, indicating

no other issues.

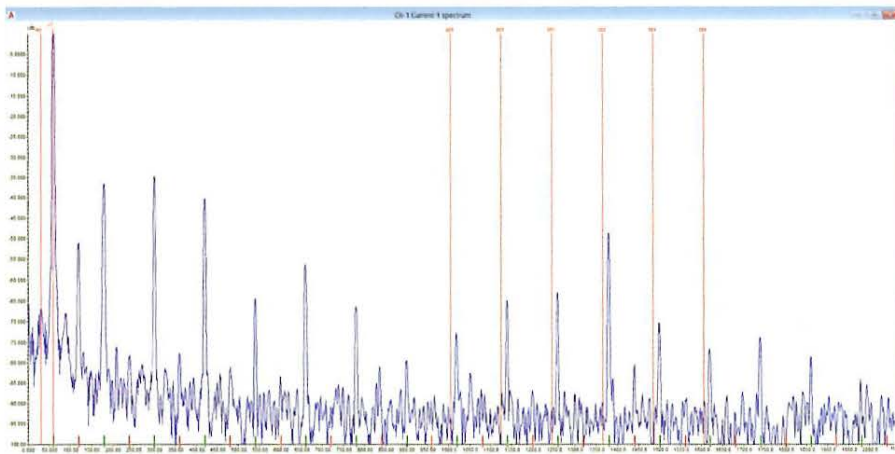
Figure 3. Testing for static eccentricity in the high frequency spectrum.

The three red vertical lines in Figure 3 relate to the running speed times, the number of rotor bars and then line frequency sidebands around that point. This is directly related to static eccentricity. As noted, the lines do not fall across these peaks and, instead, these peaks relate to line frequency harmonics as multiples of the applied 60 Hz.

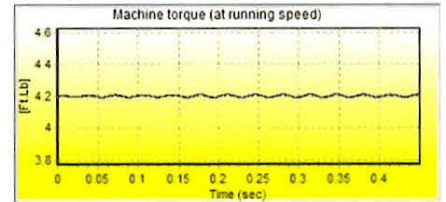
Figure 4. Torque ripple at running speed.

Figure 4 relates to the torque ripple at running speed of which there will be some level in most applications. In this case, the torque line is nearly flat with little variation, meaning that the motor is running relatively smooth. The small amount that exists comes from a variety of conditions from fluid flow to power harmonics.

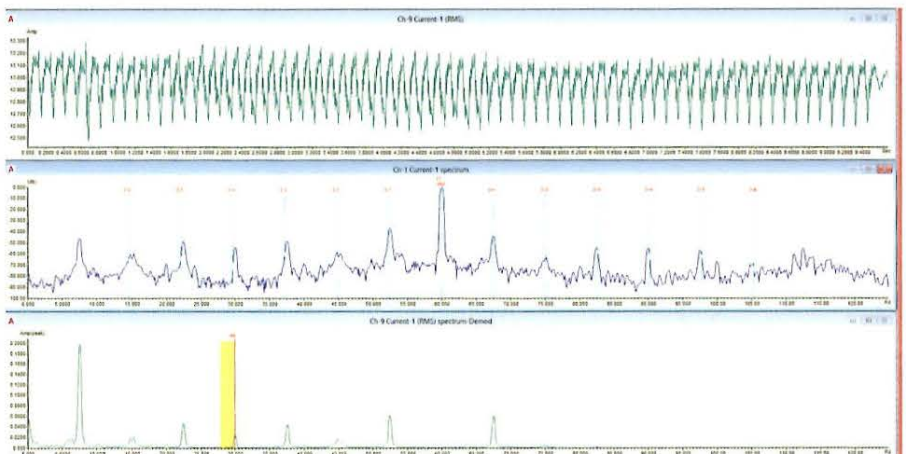
When comparing Figure 5 to Figure 2, it is immediately apparent that there are significant differences. There are a series of peaks surrounding the line frequency peak and the RMS current is very choppy. By comparing the seal signatures between the two figures, it can be seen

Figure 5. Bad low frequency ESA results and seal issue.

that a seal issue may occur soon and the high peak close to 5Hz, which has a raised noise floor in the middle spectra, means that something is going on around the impeller. The harmonics that are seen that are direct sidebands of this frequency often indicate some kind of impact or rubbing.

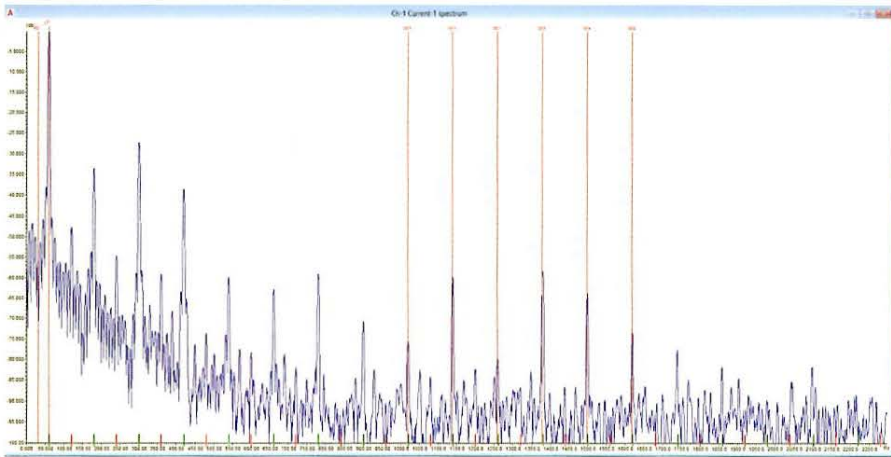
Figure 6. Static eccentricity.

In the case of the second pump compared to the first pump, Figure 6 shows definite static eccentricity, which means the motor rotor is running to one side of the stator. In fact, the situation is a little more serious as shown in Figure 7,

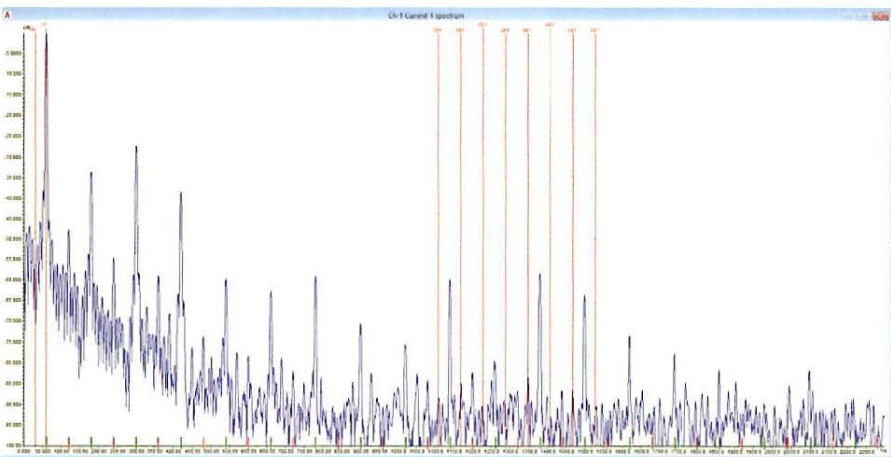
Figure 7. Dynamic eccentricity.

which indicates running speed sidebands around these peaks and dynamic eccentricity, or orbiting of the rotor within the air gap.

While rather low, it is still present which may indicate a bent shaft or some other condition that is causing the rotor to operate off centre.

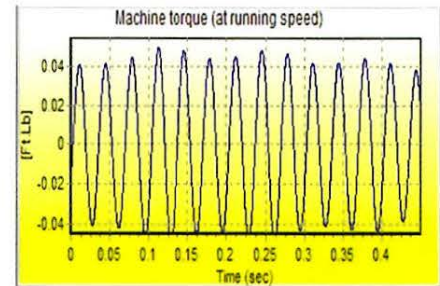
Figure 8 is the torque ripple at running speed which is surprisingly low. This can help the analyst come to the conclusion that something is happening at the impeller that is causing some level of rub and is either the result of a bent shaft,

Figure 8. Torque ripple of bad pump.

indicated by the dynamic eccentricity, or that the rubbing impeller is causing the dynamic and static eccentricity, such as if it were loose or crooked on the shaft. In either case, there is justification for removing the pump from service.
