SMRP Volume 9, Issue 5
FEB. 2015
THE MAGAZINE
BY PRACTITIONERS FOR PRACTITIONERS

RELIABILITY CONSIDERATIONS FOR WIND TURBINE GENERATORS

BY HOWARD W PENROSE, PH.D., CMRP
DREISILKER ELECTRIC MOTORS, INC.

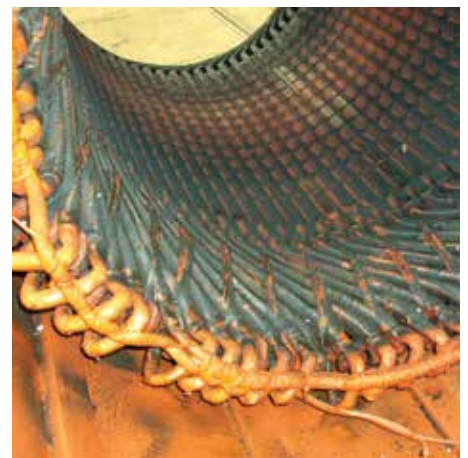
One of the observations that has provided misleading root-cause-analysis of machines is the quick and easy identification of missing wedges in a slot and a failure that has occurred in that immediate area. Normally it will be a short to ground between the top edge of the stator winding and the core of the machine. This has also been noted in the literature [2],[3], with a great deal of effort being put into the manufacture and placement of magnetic wedges, primarily in induction and DFIG generator systems. However, as is usually the case, the obvious is not always the answer.

We performed a series of investigations across a number of manufacturers plus evaluated published results of generator failure investigations, which are rare. The primary reasons relate to the manufacturers keeping the failure information relatively close. The results are quite different than those published, when a full RCFA is performed.

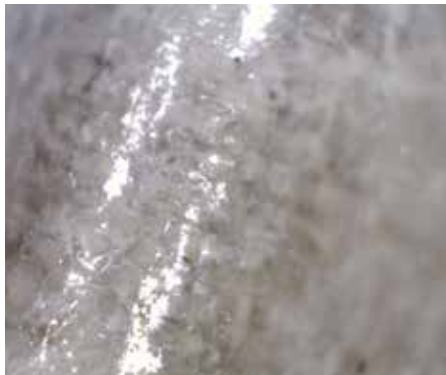
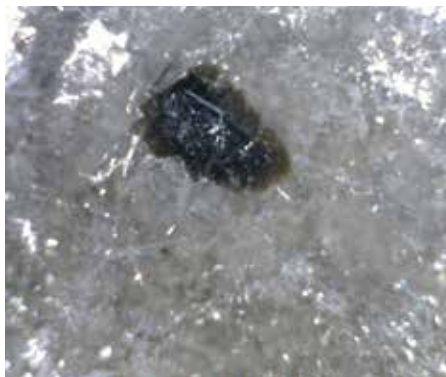
As a result of the significant number of failures to ground where wedges have been forced out of the slot, there has been a general focus on the wedge materials and slot tightness. However, based upon the type of investigations we are performing, we approached the wedge failure as a symptom and not the root-cause. The end result of this string of the investigation was that the wedges came out of the slots and material collected in the slots of which some became magnetic termites. After some period of time, the termites would generate a path until the insulation system failed. In some instances, the wedge would wear against the insulation system until it became weak enough to short to ground.

As we are performing forensics, this information was valuable, but we needed to know why the wedges were coming out in some slots and not in others and, in some machines, would progress around the circumference of the machine.

In general, it was found that due to the operating conditions the winding systems in a wind generator, and the associated mechanical systems, must hold tighter tolerances. Insulation systems, including slot-packing systems, must be chosen in order to maintain tension between the coil and slot system regardless of the thermal changes. The overall mechanical system must be capable of withstanding the overall dynamic mechanical, electrical and thermal stresses inherent in the wind generation system.
