# Forensic Analysis of a Silicone Oil Filled Mobile Transformer

Howard W Penrose, Ph.D., CMRP  
SUCCESS by DESIGN®  
Naperville, Illinois USA  
Old Saybrook, Connecticut USA

**Abstract-** When a number of new silicone oil filled mobile transformers failed, an evaluation of one of the remaining transformers was commissioned. The forensic analysis involved the tear-down and evaluation of the working transformer and components. In this paper we will discuss the steps involved in developing this type of forensic analysis, a few of the findings, and recommendations. Problems identified a range from design issues through to insulation coordination issues that did not cause the initial failures, but were identified as high risk future issues.

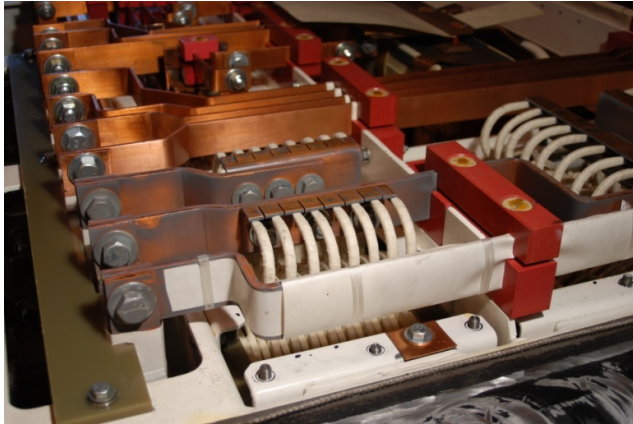
Fig 1: Grey Matter on Bus Bars

As noted in Figure 1, a grey deposit existed throughout the transformer. Several possibilities were considered and a sample was sent for laboratory review.

The material was identified as mainly made up of silicone, aluminum, copper, iron, zinc, magnesium, calcium, sodium and titanium (Table 4). The material was attracted to the bus bars with the metal being made up primarily of the same material as the bolts/threaded rods throughout the transformer. The generation of the material was estimated as having been the result of movement between the threaded rods and suspension springs located with the component buckets (Fig 2).

A majority of the grey material was on a specific electrical filter that should not have been carrying significant current. This allowed the facilitator to identify potential capacitor filter calibration issues, which were reported.

- Periodic tuning of the filter capacitors would be required versus the one-time set up tuning presently performed;
- Several options for mitigating the existing conductive material were presented, but not pursued, due to additional investigations;
- An insulation coordination study must be specified in the original purchase of future transformers;
- The existing insulation system must be replaced upon failure of each transformer, if not before;
- Acceptance criteria for dissolved gasses and particulate must be agreed to by both the vendor and owner; and,
- The bucket suspension system must be modified to eliminate metal from permeating the oil due to fretting.

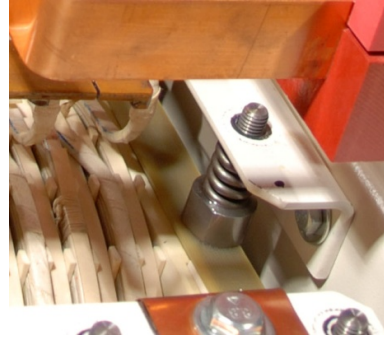
Fig 2: Fretted Bolts and Buckets

It was noted that there was no guide or material between the threaded rods and there were visible signs of fretting.

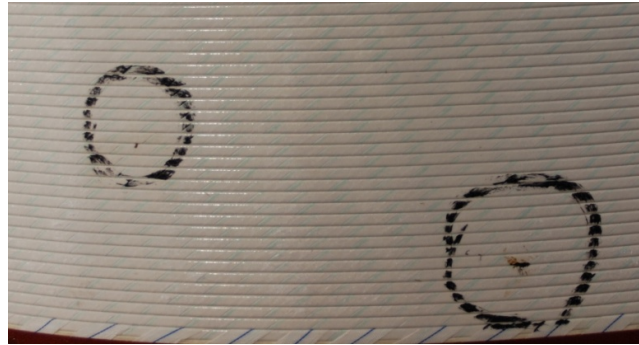
Fig 3: Burn Spots Between Primary Conductors

One coil was removed from the transformer in order to evaluate the primary. Once the outer insulating paper was removed, it was noted that the varnish impregnated paper around each bare copper wire was tacky. It was also noted by the facilitator that the enamel on the secondary conductors was sloughing off. It was discussed and determined that the sample coil should be unwound by hand.

As identified in Figure 3, there were ‘burn spots’ throughout the primary between conductors in the center layers, with the copper conductors visibly pitted directly underneath. There were other areas where the grey matter could be found attached to the tacky insulation paper. It was determined that the ‘arcing’ noted in the oil samples may have resulted from these indicators. It was also noted that the pictures in the first transformer failures showed the faults occurred in roughly the same area as the ‘burned’ spots in the sample primary. The tackiness was attributed to possible incompatibility of the conductor varnish with either the silicone oil or the dissolved gasses.
