# Insulation System Reliability in Wind Generation

Howard W Penrose, Ph.D., CMRP  
President  
Success by Design  
Lombard, IL, USA  
hpenrose@motordoc.com

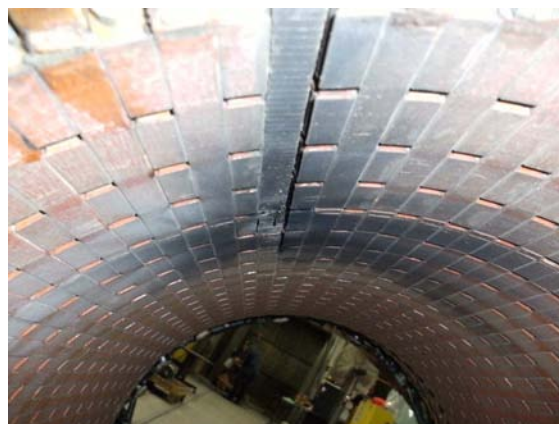
The initial observation identified a common symptom of the stator winding failures associated with both DFIG and IG machines and similar between the two rotor winding failures of the DFIG. The failures were all coil to ground at the top of the slot and associated magnetic wedge material was missing from the slot. There were also several conditions that went along with these machines. In some cases, only the wedge associated with the winding failure was missing, in other cases, a large number of wedges were missing, including the area where the coil failed. In all cases, the wedge material was missing where the coil failed as shown in Fig 1.

Fig. 1. Failed Stator Coil with Missing Wedge

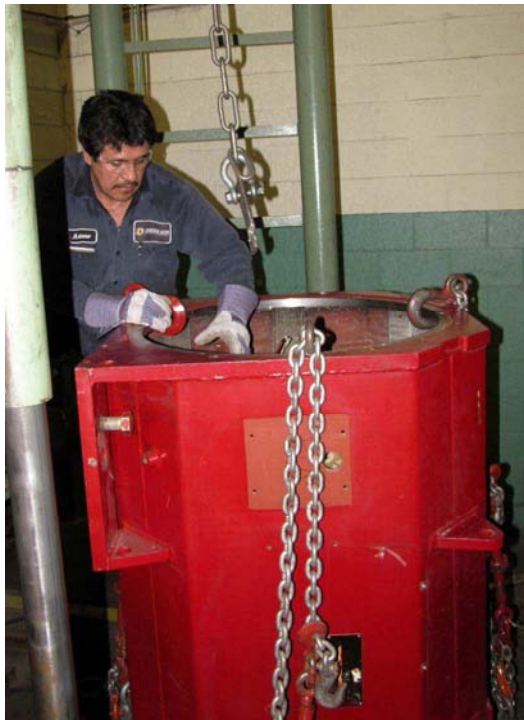
Fig. 2. Stripping Generator Vertically

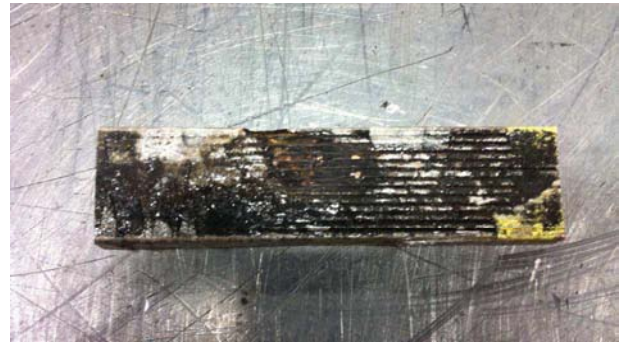
Fig. 3. Inspection of a section of failed coil after tape removal showing surface damage on conductors only indicating ground fault

As shown in Fig. 3., all of the coils were found to have failed single turn to ground versus turn to turn shorts. The potential causes that were investigated on each machine included:

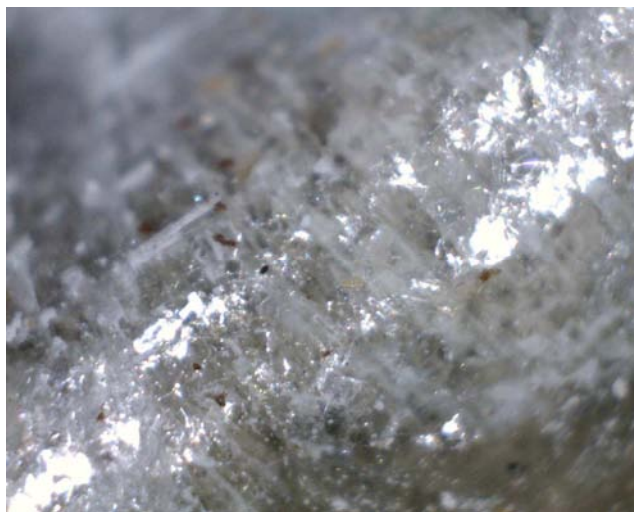
Sections of good and bad coils were made and the material peeled back layer by layer and inspected by microscope. The small brownish objects shown in Fig. 4. are iron particles that have 'tunneled' their way into the insulation system. This symptom tended to be found along the top edge of coils where the wedges were missing and magnetic wedge iron dust had gathered.

Fig. 4. Iron filings and pathways several layers deep into mica tape along top edge of top coil.

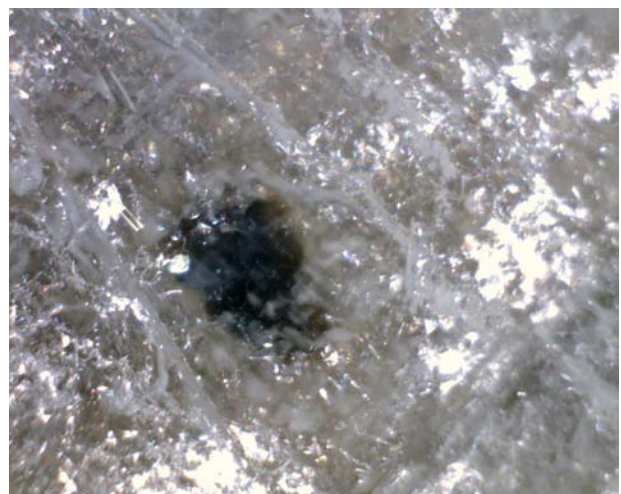
During a period of time in operation as the generator cycles, in particular in times of thermal extremes, the insulation system begins to release. Forces on the coils are radial against the spongier packing materials and the material begins to compact, increasing the forces acting against the wedges. Eventually one or more wedges break loose from the slot either due to the brittleness of the wedge or the wedge acting against the wedge slot wears it open. The wedge drags on the rotor causing iron particulate to spread throughout the generator and some to gather in the open top of slot against the direction of rotation. The iron begins to drill its way into the insulation system eventually creating a path to ground or allowing electrical sparking and insulation degradation (Fig. 5.).

Fig. 5. Arcing point in armor tape resulting in burned mica tape.

Keeping the magnetic wedge but improving coil and packing materials may be a better solution.

The magnetic wedge is less likely to vibrate and fail if a constant tension is kept on it. This opens several solutions that can be implemented both on the new manufacture and overhaul of an electric machine:

- Larger machines may have the opportunity to use ripple springs as side and top packing. This provides the additional benefit of maintaining constant tension across significant temperature ranges. The stator may still be VPI'd with the use of ripple springs.
- Tighter top and side packing for smaller machines using solid materials such as Nomex®. This may mean that wedges will have to be manufactured in shorter sections versus one or two long wedges.
- Shorter wedges that conform better to the wedge slots in order to reduce the amount of wedge vibration.
