## **Mechanical Impact of High Temperature Stripping Of Induction Motor Stators**

**Howard W Penrose, Ph.D., CMRP**  
**Vice President, Engineering and Reliability Services**  
**Dreisilker Electric Motors, Inc.**

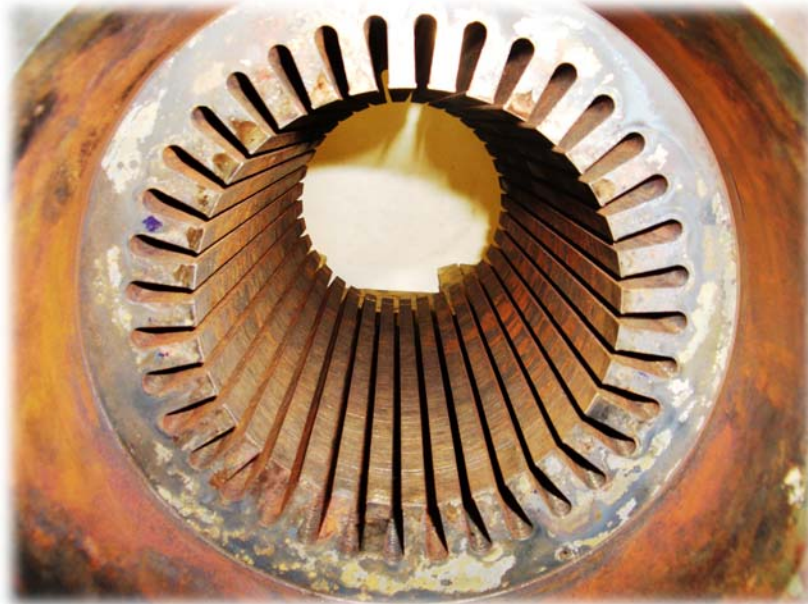
Figure 1: Burned Out Stator Core

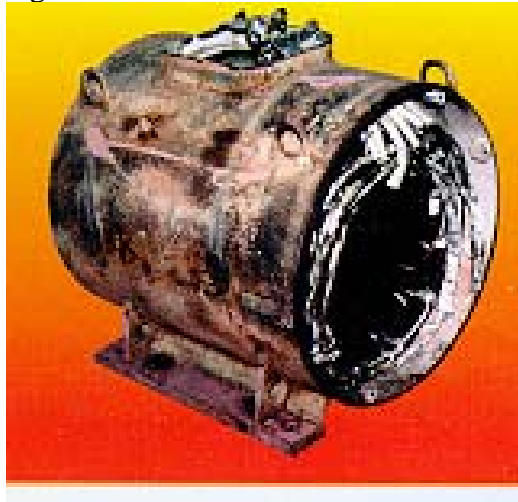
Figure 2: Burned Out Rolled Steel Stator

As there was a significant increase in soft foot and stator deformation in the aluminum stators at 650F, the 800F test was performed on cast and rolled steel stators only. There were significant changes in soft foot, rabbit fit concentricity and core steel position. Visually, the stators and some warping and oxidation was found on all stators within two days. There were severe instances of loose laminations in all of the stators.

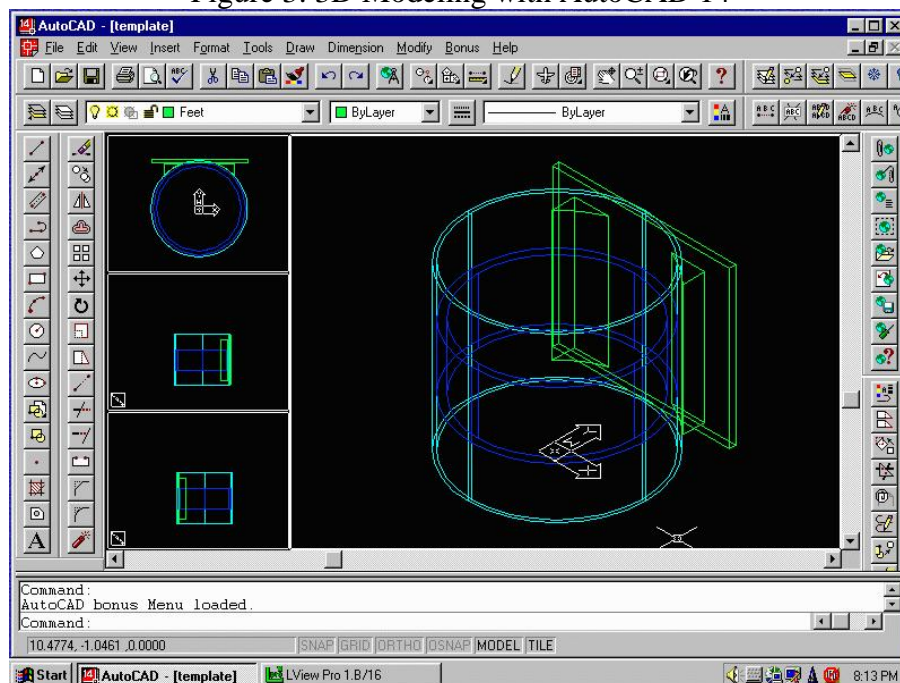
Figure 3: 3D Modeling with AutoCAD 14

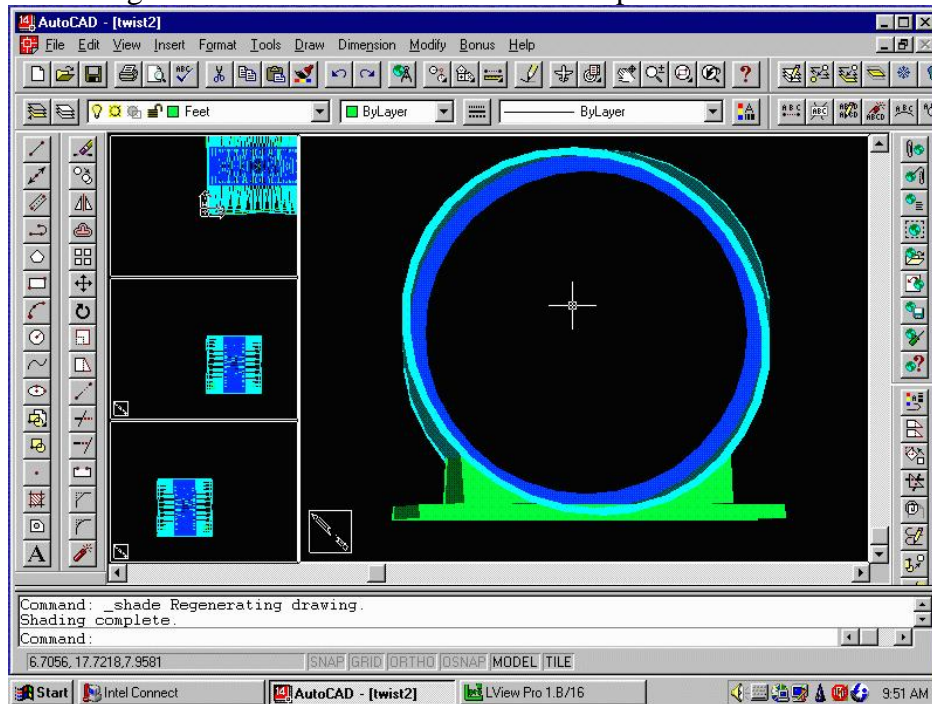
Modeling the results created an understanding of what was truly happening to a motor in which even minor distortion was occurring. Those results were fairly dramatic and go a long way to help determine why some repairs do not seem to last as long as others.

Figure 4: Model Modified in AutoCAD per Measurements
