Generator REPAIR 101

Finding a failure's real root cause

Why wind generators die young and how to make them work longer

Howard W Penrose

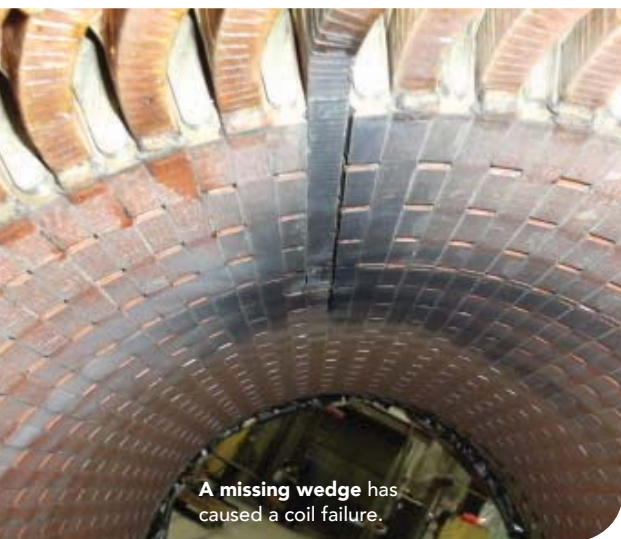
A missing wedge has caused a coil failure.

important to note that in every stator winding failure, the fault was to ground. What's more, it was clearly visible where wedges had worked free of the associated slot and that there were no failures around loose or solid wedges (see accompanying image).

The magnetic wedge is less likely to vibrate and fail if constant tension is applied to it. This opens a number of solutions that can be implemented during new manufacture or during a generator overhaul. For example:

- Larger machines may have the opportunity to use ripple springs as side and top packing. This provides the additional benefit of maintaining constant tension across significant temperature ranges. The stator may still be VPI'd with the use of ripple-spring packing and in higher voltage applications, semi-conductive ripple springs are available.
- Tighter top and side packing for smaller machines using solid materials, such as Nomex. This may mean that wedges have to be manufactured in shorter sections versus one or two long wedges.
- Shorter wedges that conform better to the wedge slots to reduce the amount of wedge vibration along with rigid packing.

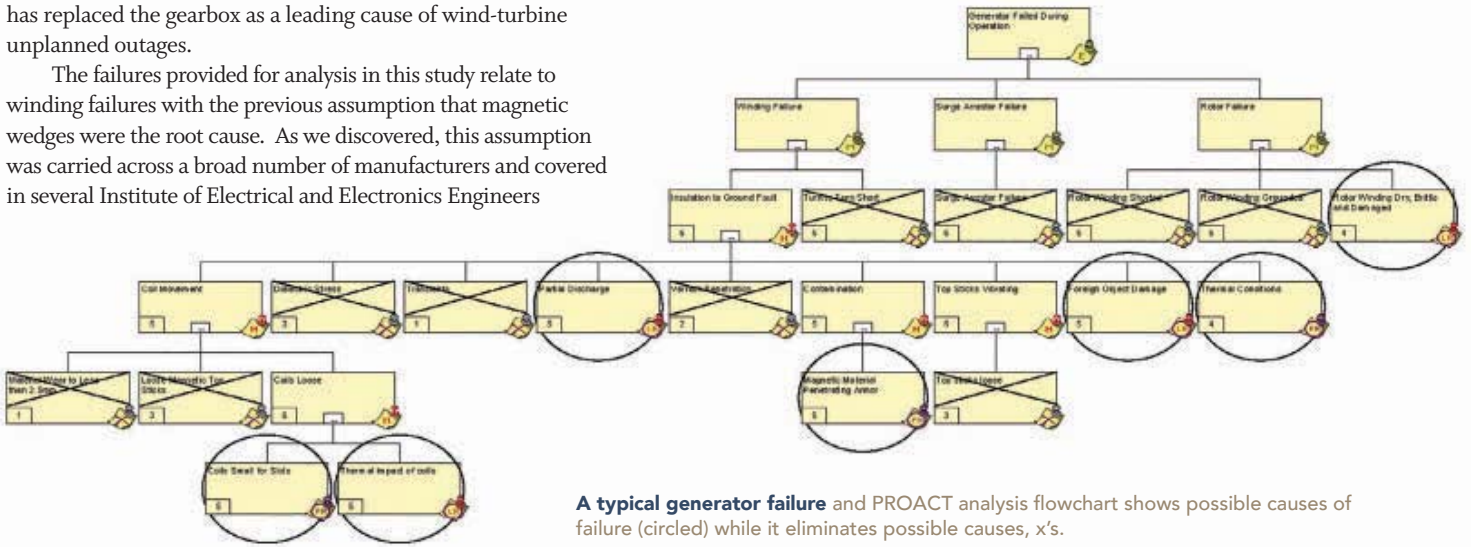
A typical generator failure and PROACT analysis flowchart shows possible causes of failure (circled) while it eliminates possible causes, x's.

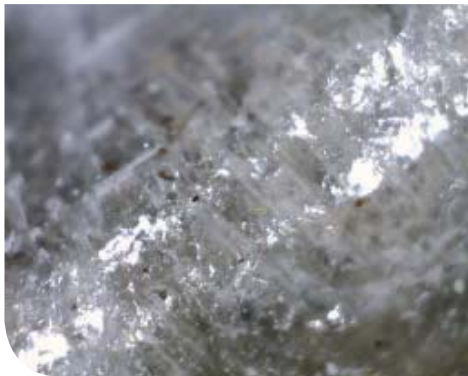
The brown material is iron dust and some other evidence of tunneling caused by what's called magnetic termites.

The investigation was conducted on intact and missing wedges. A collection of magnetic dust or iron from the missing wedges had gathered in the direction of rotation at the top edge of the coils, including near the point of failure inside the stator. Magnetic materials show a peculiar effect when exposed to alternating current fields: they tend to spin. In this case, the point where every generator inspected had failed was along the top

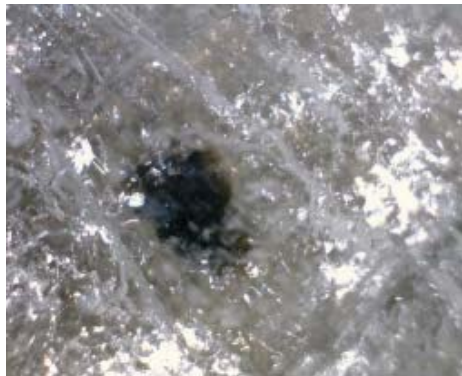
Burned material in insulation layers as magnetic termites gather at a single point.

edges of the coils, iron dust was collecting and penetrating the insulation as if it were magnetic termites. In a few places, enough material was gathered to generate hot spots in the insulation system, burning the insulating material. In all cases the varnish penetration in the coils was excellent.
