# **Electric Motor Connection Issues**

## Howard W Penrose, Ph.D., CMRP President, SUCCESS by DESIGN Reliability Services Executive Director, Institute of Electrical Motor Diagnostics, Inc.

## **Richard Borge President, Performance Evaluation, LLC**

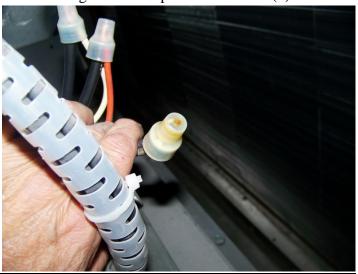
In this first case, an electric motor in a commercial building would occasionally trip both when the motor was started and during motor operation. When tested using Motor Circuit Analysis, no problems could be detected and insulation to ground issues were not identified. Following the tests, the motor was re-started and the motor immediately tripped. In an effort to identify the cause of the problem, the connection box was opened up and testing was going to be performed at that point. However, it was immediately identified that the tip of one of the supply leads had been forced out of the tip of the crimped connection (Figure 1).

Figure 1: Crimped Connections (1)

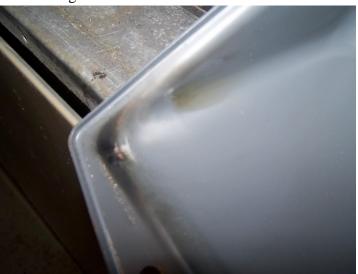
While this does not appear as if it is severe, it only took this small amount of insulation to have broken down over time to cause the motor to arc to the inside of the connection box (Figure 2).

Figure 2: Connection Box Fault Point

The initial consideration in this fault was that the nuisance tripping might have been caused by a pinhole short in the insulation system, as it was a variable frequency drive application. If the technician had decided to swap out the motor, and the connection had been cut without noticing

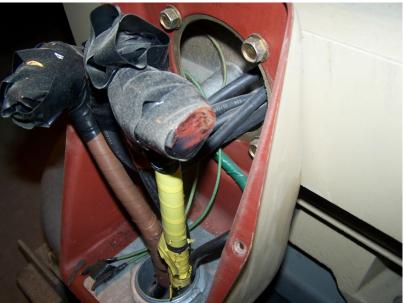
Often times short cuts are taken, such as in this case. When making connections, electrical tape alone will not suffice. It does not afford protection when vibration, contaminants or moisture get into the tape and generate a path to ground. The result is the same as what occurred in both issues 1 and 2 above. In this case, you will also note the less than professional taping job.

Figure 5: The Results of Electrical Tape Only
