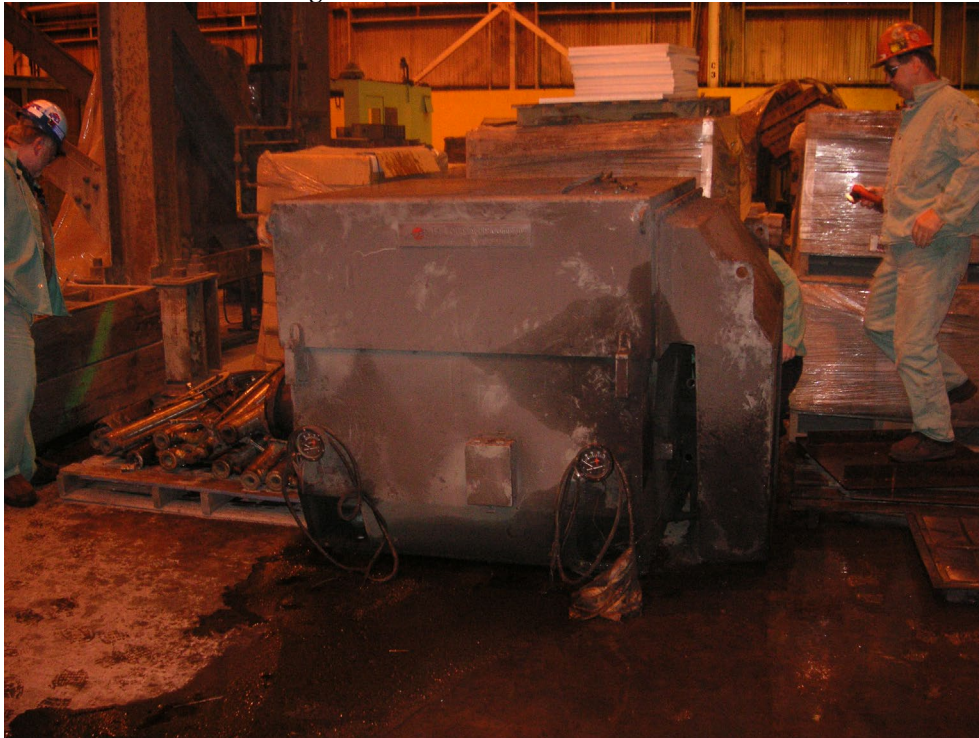
**Figure 1: #4 Combustion Fan Motor**

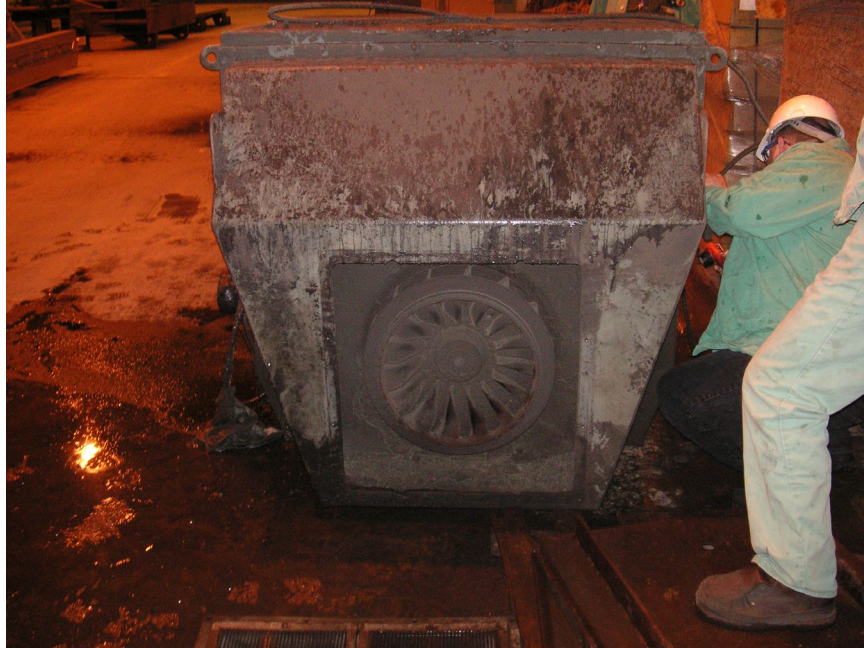
The initial inspection was performed on the floor of the mill. The lead connections had been severed. An ALL-TEST Pro 5 Motor Circuit Analyzer was used to evaluate the existing condition. The winding was found to be severely damaged with a direct short to ground. A visual inspection was performed.

**Figure 2: Lead Inspection**

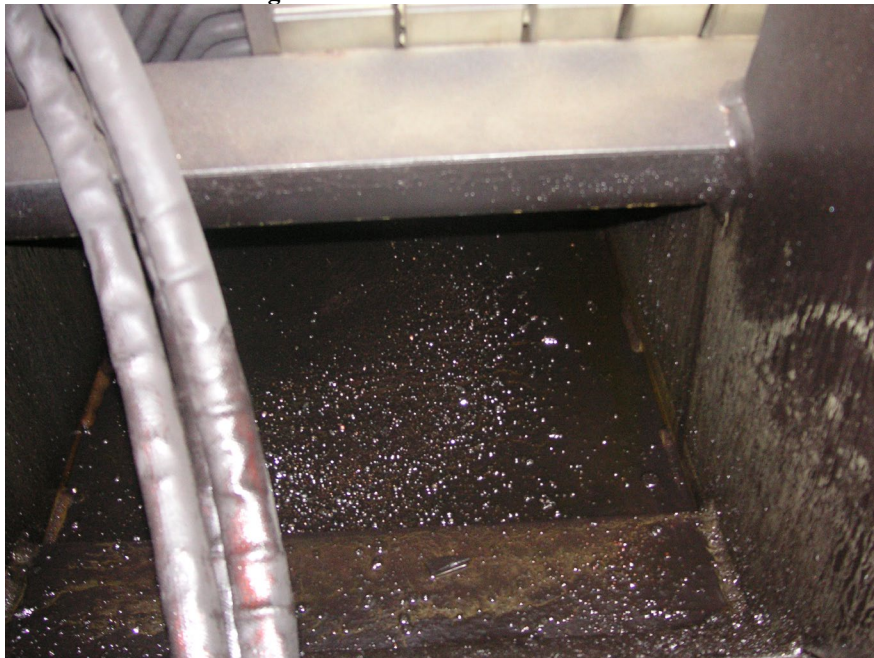
**Figure 3: Interior Bottom of Motor**

Figure 3 identifies copper balls on the bottom of the motor related to a catastrophic winding failure. The inside wall of the motor on the right side of the picture identifies the ‘water line’ of oil that was trapped in the motor.

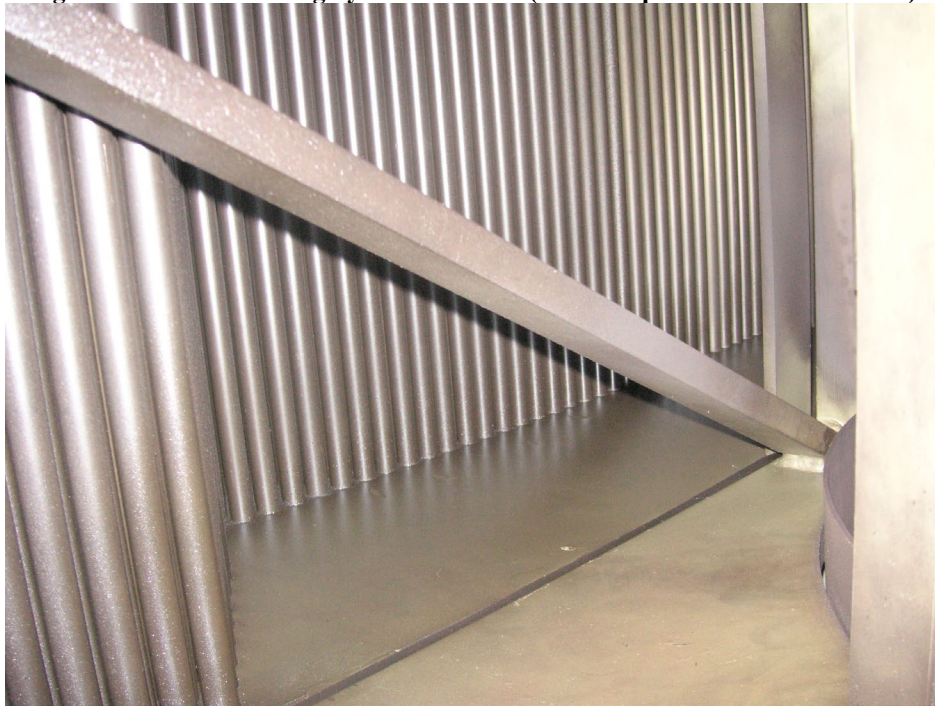
**Figure 4: Interior Cooling System of Motor (Picture up from Connection Box)**

Figure 4 identifies the cooling tubes which provide heat exchange with the air within the motor. Fans on the motor rotor cause the air to move within the stator and through the cooling coils. Air moving from the fan through the inside of the cooling coils carries the heat out from the electric motor. The cooling coils inside the hood of the motor are relatively clean.

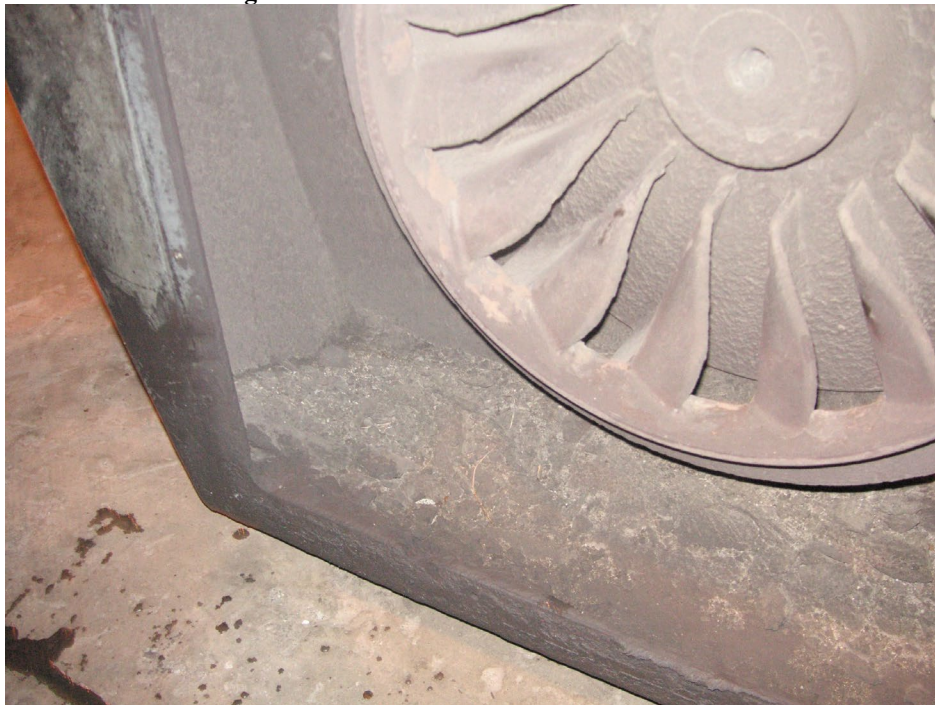
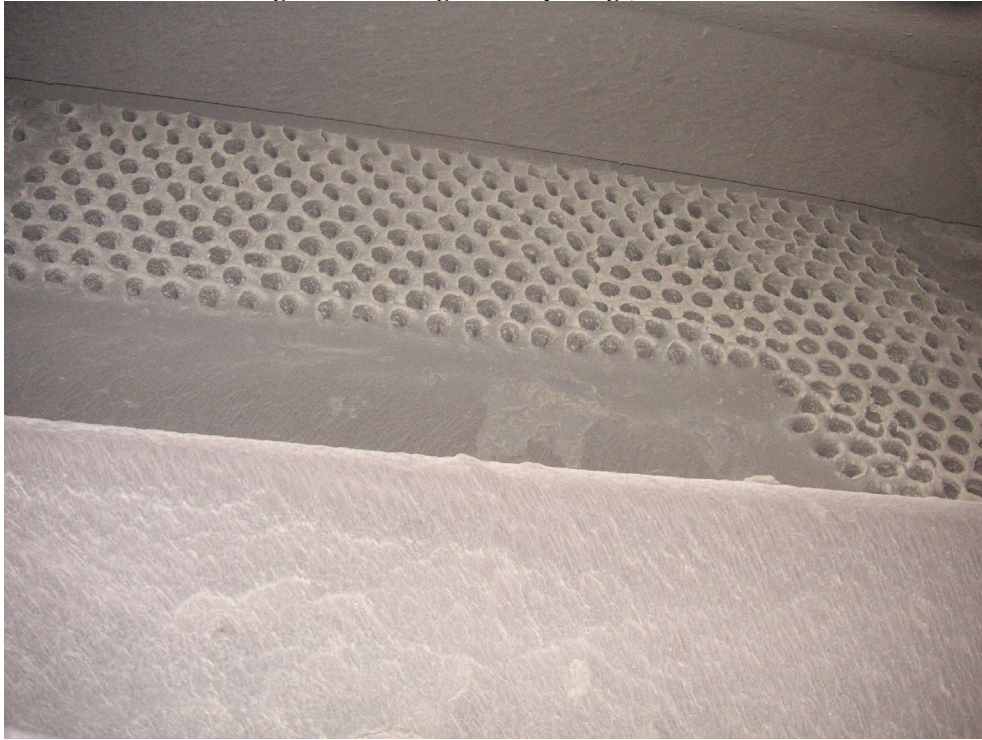
**Figure 5: Fan Condition and Contamination**

**Figure 6: Cooling Tube Openings, Fan End**

Figures 5 and 6 identify the contamination prevalent through the air-cooling system, clogging the ability of the motor to cool itself.

1. Cleanliness:
  - a. Periodic cleaning of fans and cooling tubes, at least quarterly;
  - b. Install a filter system to prevent contamination entering the motor cooling system and schedule periodic cleaning/replacement of the filter medium;
  - c. Monthly visual inspection of the motor cooling system and cleaning based upon condition; and/or,
  - d. Repair doors to motor area in order to prevent contamination from entering the motor cooling system.

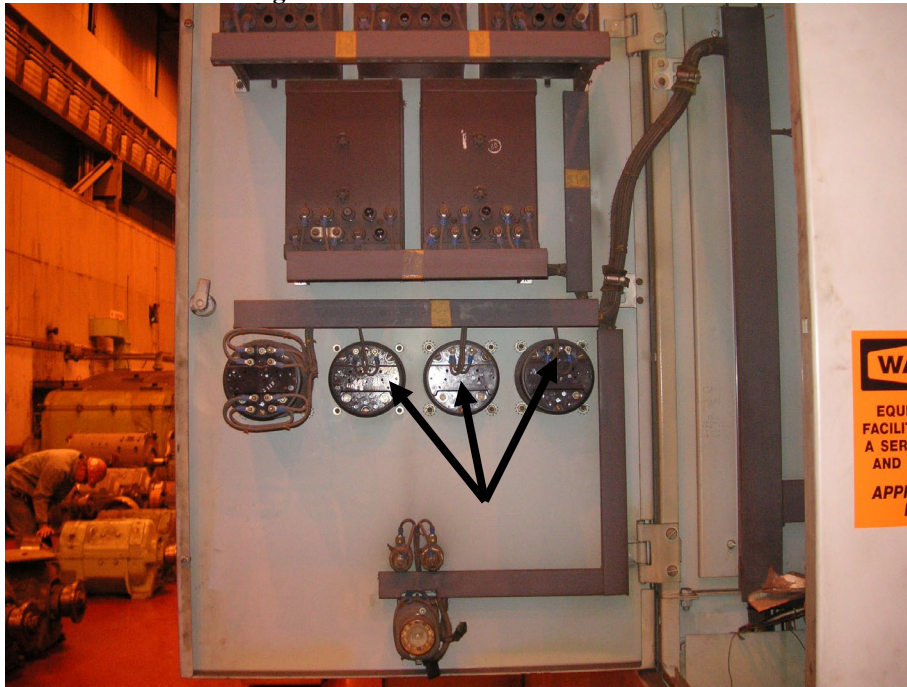
Electrical Signature Analysis (ESA) with the EMPATH system was performed on the three remaining combustion fan motors and on the spare combustion fan that replaced the original Combustion Fan #4. As shown in Figure 7, the only data that could be safely taken was current signature data. In each case, fan frequencies were identified showing some level of fan unbalance and loose coil signatures.

**Figure 7: ESA Data Collection Points**

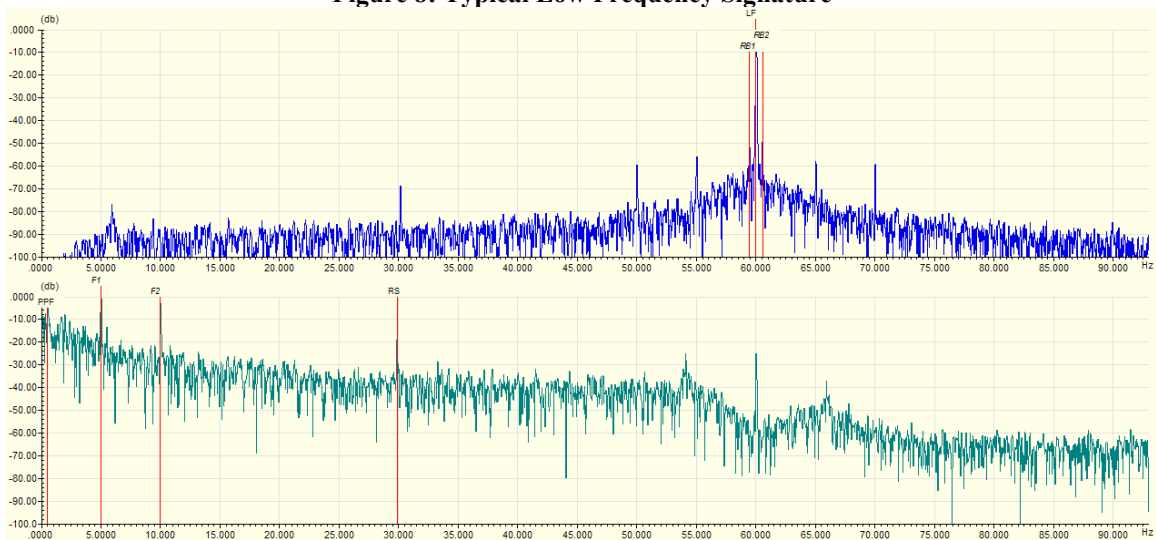
**Figure 8: Typical Low Frequency Signature**

Figure 8 represents the low frequency (<100Hz) signature from Combustion Fan #2. RB1 and RB2 identify Pole Pass Frequency (PPF) signatures around line frequency. These peaks identify fractures in at least one rotor bar and this situation should be monitored with the fan under load. F1 and F2 identify fan unbalance signatures which identify that the fans on the motor and the combustion fan should be cleaned. RS represents the running speed, and the height of the peak identifies that the direct drive fan and motor are mechanically imbalanced. Based upon the general cleanliness of the failed Combustion Fan #4, cleaning of the fans, cooling tubes and combustion fan may be what is required to correct any unbalance.

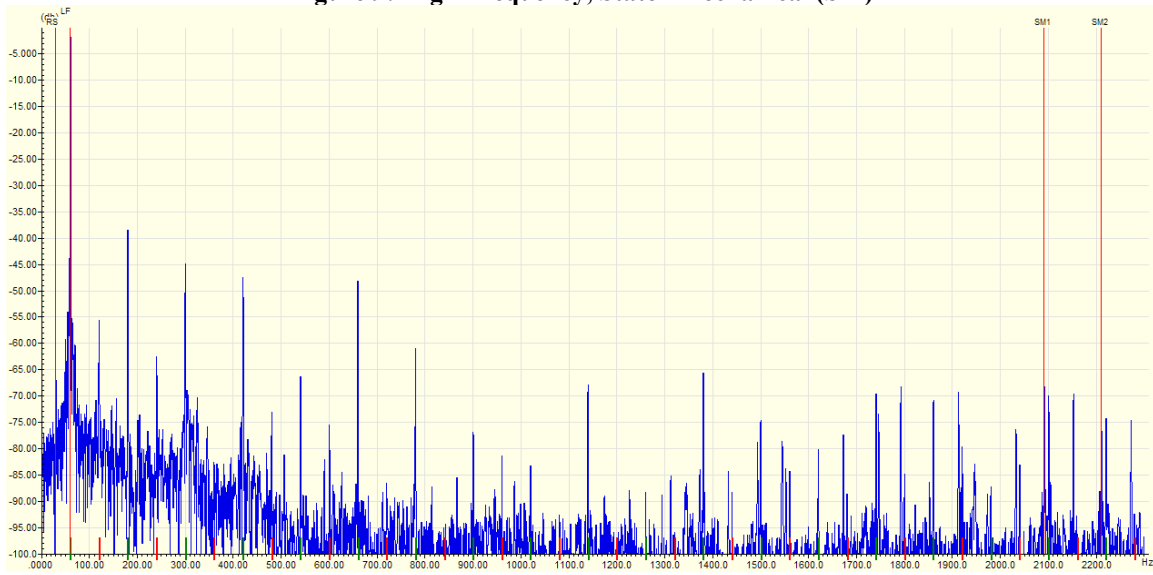
**Figure 9: High Frequency, Stator Mechanical (SM)**

The peaks entitled SM1 and SM2 indicate ‘Stator Mechanical’ issues that are prevalent in all of the combustion fan electric motors. These peaks normally indicate movement of the stator coils.

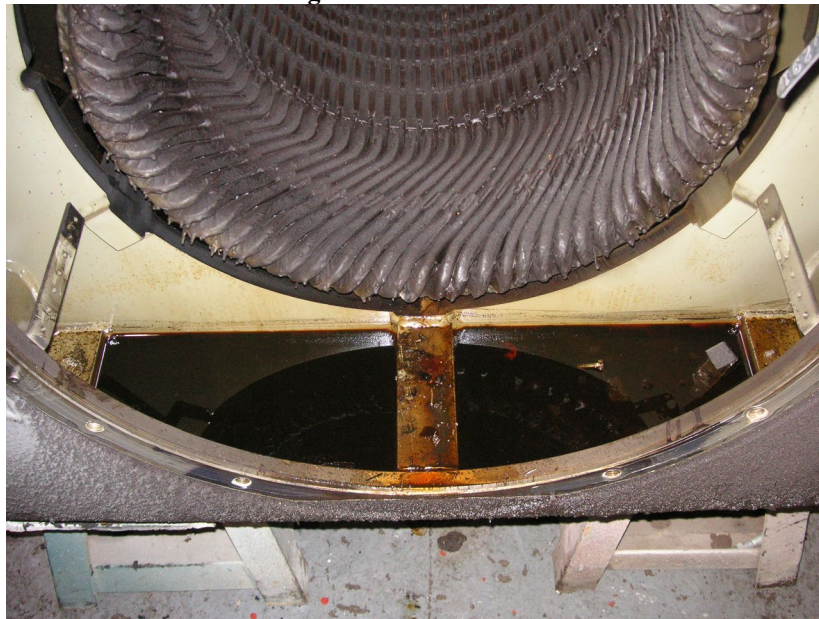
**Figure 10: Oil in Motor**

As shown in Figure 10, oil was introduced into the motor through the bearings. The oil level in the motor had reached the level of the windings as shown as a 'water line' in the motor. At the time of motor disassembly, approximately 1-2 inches of oil remained in the motor. Figure 10 identifies the winding at the drive end of the motor where oil had been leaking directly onto the windings.

2. Oil Leakage Into Motor:
  - a. Periodic inspection of the interior of the motor to see if there is oil in the bottom of the stator housing; or,
  - b. Quarterly motor circuit analysis (de-energized winding test) in order to determine if contamination is effecting the winding.
3. Evaluation of the condition of the motor windings:
  - a. Electrical Signature Analysis to monitor winding mechanical movement; and
  - b. Motor Circuit Analysis to monitor winding insulation system condition.

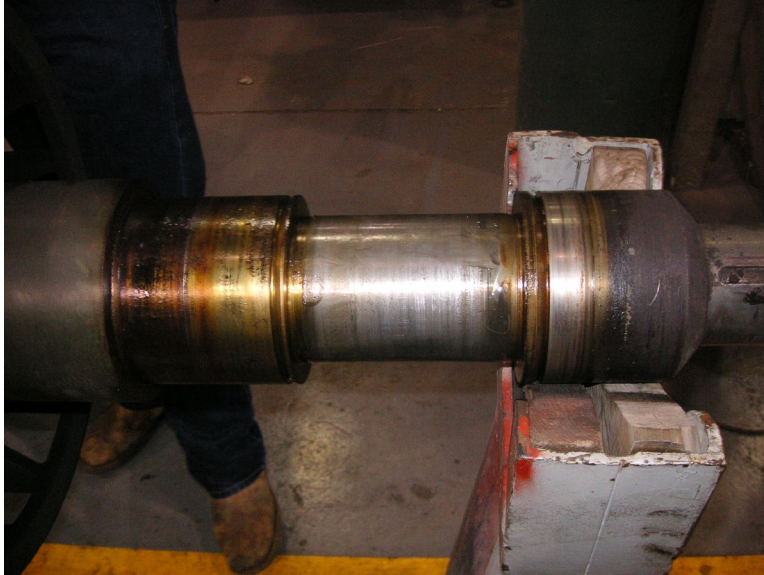
**Figure 11: Failed Seal Surface on the Rotor**

The rotor side seal surface of the rotor for the bearing failed, as shown in Figure 11. This appears to be the result of poor original (OEM) seal dimensions which allowed oil to enter the motor.

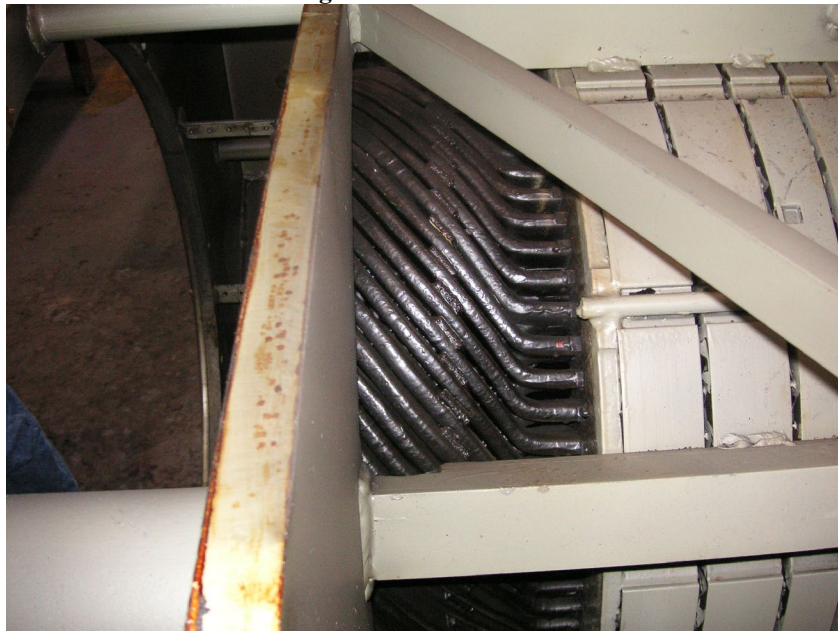
**Figure 12: Motor Coils**

Figure 12 identifies the coil end-turns and the blocking involved. Just out of site, under the metal stator strut, is the surge ring, which is a band around the outside of the coils in order to provide additional mechanical strength. The blocking and position of the surge ring are insufficient to properly hold these coils, mechanically, allowing movement which explains the EMPATH Mechanical Coil signatures. This movement can cause stress fractures in the insulation system at various points of the end-turns of the coils, in particular where they exit the stator slots.

The issues related to loose coil ends and poor welds would have to be repaired through rewind repair, possibly following motor failure.

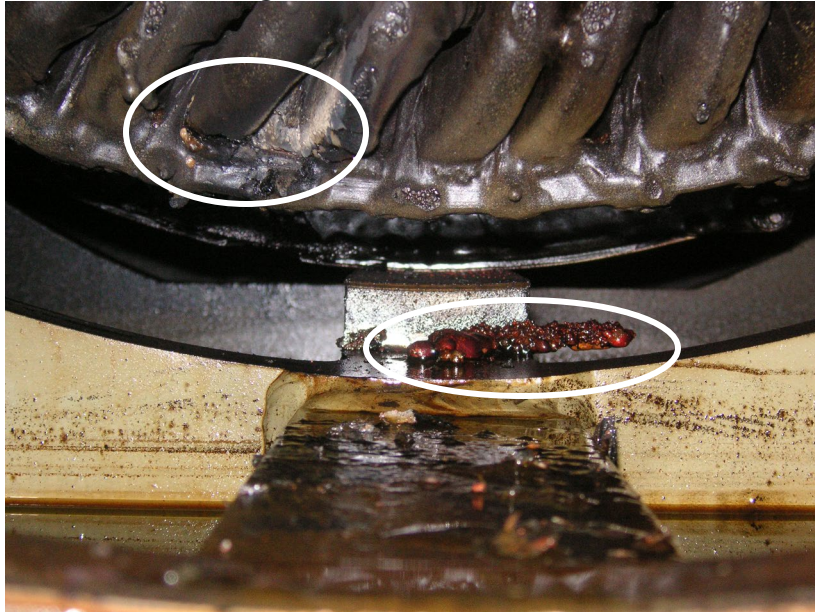
**Figure 13: Failed Coil Material**

The material below the windings in Figure 13 is copper that had been melted at one of the winding failure points seen in the upper left at the surge ring.

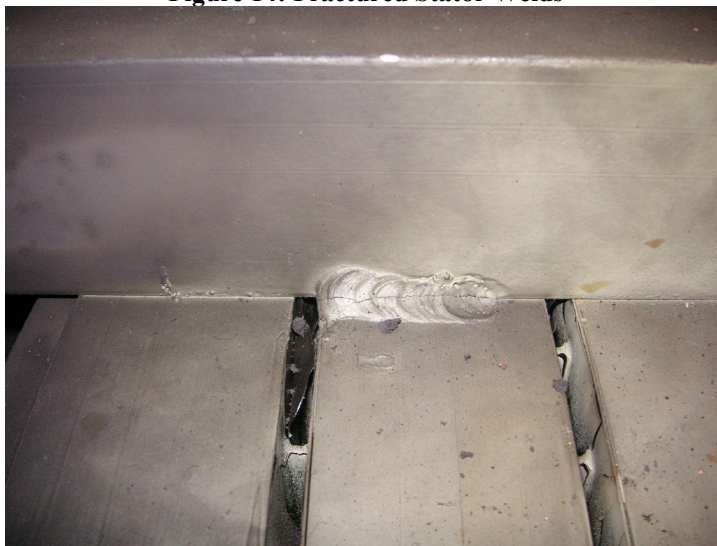
**Figure 14: Fractured Stator Welds**

The fracture cited in Figure 14 is prevalent in all welds between the stator frame and stator core.

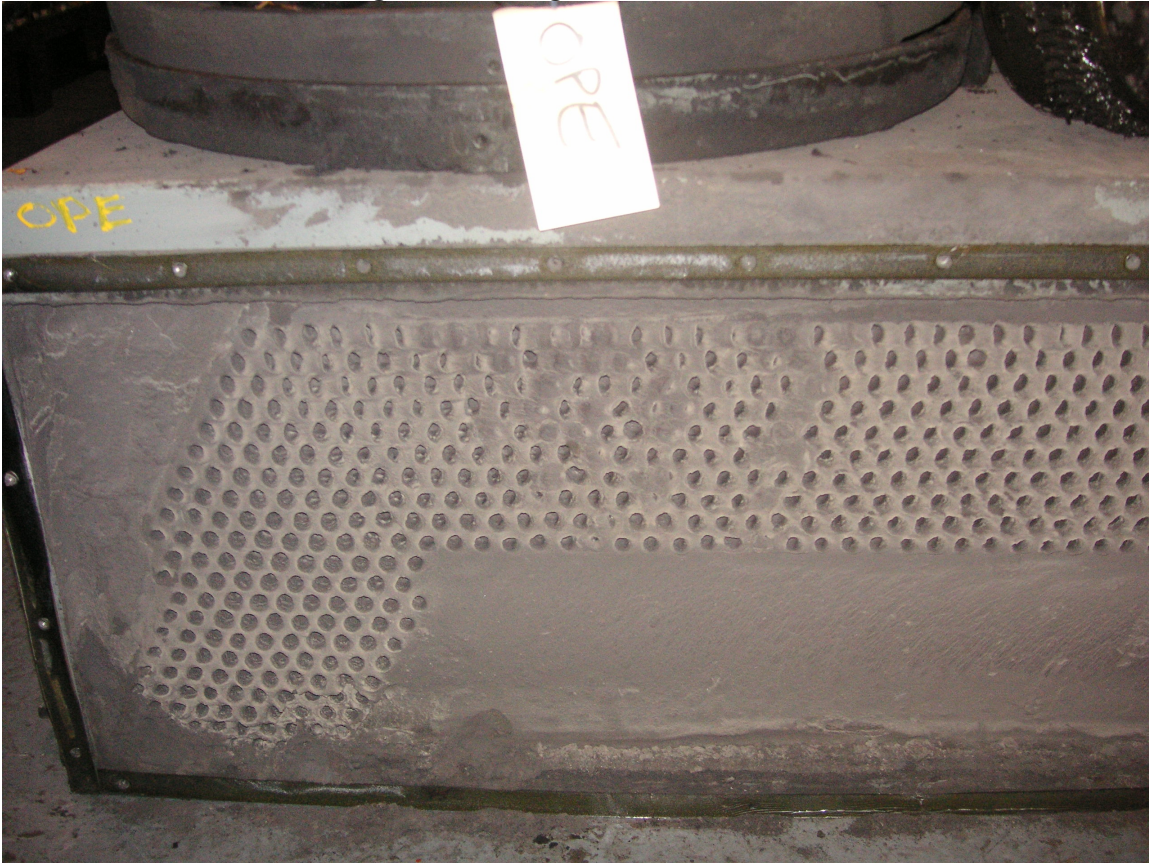
**Figure 15: Cooling Tube Contamination**

Figure 15 identifies the contamination blocking the cooling tubes in the top of the electric motor. This cooling issue most likely accelerated the failure of the motor windings as shown in the darker winding spots as shown in Figure 12. This material is loose and can be removed easily by hand.
