THE MECHANICAL EFFECTS FROM THERMAL STRIPPING INDUCTION MOTOR STATORS

Howard W. Penrose, MsE
TK Design Technology, Inc.

Abstract: This paper describes the mechanical effects that result from the thermal stripping of induction motors. The study involved a variety of frame sizes and stator materials from a number of manufacturers.

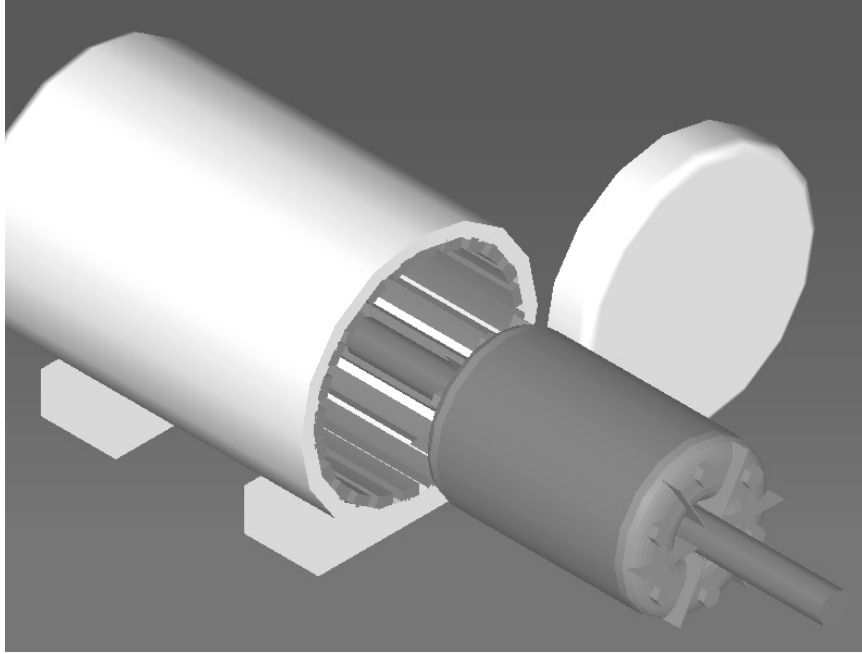
Three Dimensional Motor Model

The results were formed into three dimensional models using AutoCAD Version 14 and 3D Max. The purpose of modeling was to present an exaggerated visual as well as a true dimension determination of the effects of rotor position within the stator.

Modeling the results created an understanding of what was truly happening to a motor in which even minor distortion was occurring. Those results were fairly dramatic and go a long way to help determine why some repairs do not seem to last as long as others.
