# A Novel Approach to Electrical Signature Analysis

Howard W Penrose, Ph.D., CMRP  
Vice President, Engineering and Reliability Services  
Dreisilker Electric Motors, Inc.

*Abstract: Electrical Signature Analysis (ESA), sometimes referred to as Motor Current Signature Analysis (MCSA) or Current Signature Analysis, is a method of taking voltage and current information in order to determine variations in the machine airgap and torque in order to analyze electrical and mechanical issues. With one set of readings from a motor control center, or the output of a variable frequency drive or soft start, the user can determine conditions of: power supply; motor rotor and stator; and, load. However, the data required in order to complete a full and accurate analysis is not always available. In this paper we will discuss pattern recognition in ESA in relation to the detection of faults requiring limited information or experience, although a good understanding of the system is required.*

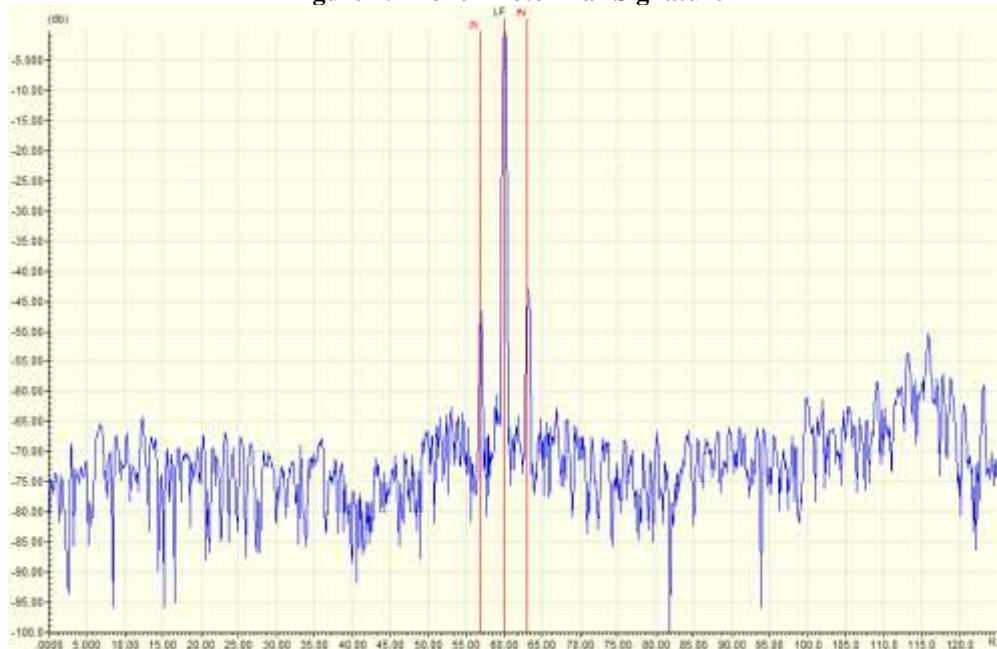
**Figure 1: Broken Rotor Bar Signature**

When the Pole Pass Frequency sidebands (P1 and P2) of Figure 1 are compared to the values in Table 1 the condition of the rotor bars can be determined. However, in this case, the motor is 4,160 Vac and the data was taken from the Motor Control Center (MCC) Current Transformers (CT). The result can be a dampening effect on those peaks resulting in the analyst needing to estimate the severity of the fault.

One of the original concepts behind the development of ESA was to eliminate the loss of instrumentation to test MOV's in the dangerous areas within nuclear power plants. The primary failure of these machines is the rotor which would overload and melt when limit switches failed. It was discovered that the rotor bar failure signature was unique enough that not only could the signature be quickly identified, but that condition values could be applied easily.

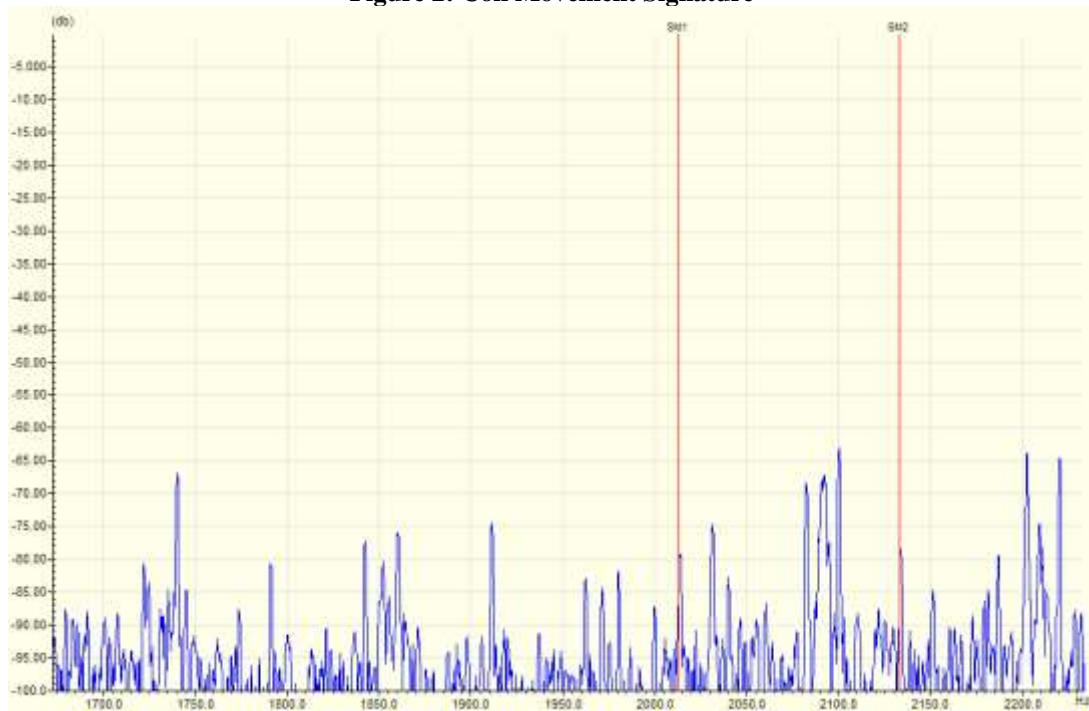
**Figure 2: Coil Movement Signature**

In figure 2, the motor is an 800 horsepower, 1785 RPM, 101 Amp, Louis Allis motor with 58 rotor bars and 72 stator slots. SM1 and SM2 are peaks related to the movement of the coil ends of the motor windings. As measured through the CT's, the values are about -78 dB which would be more severe if the current was measured directly. With an RPM of 28.793 Hz (1727.6 RPM), the stator mechanical (coil movement) frequencies would be the number of stator slots times the running speed plus and minus the line frequency. In this case, 2013.1 Hz and 2133.1 Hz which relates to the fields passing through the coils ends and interacting with the rotor fields.

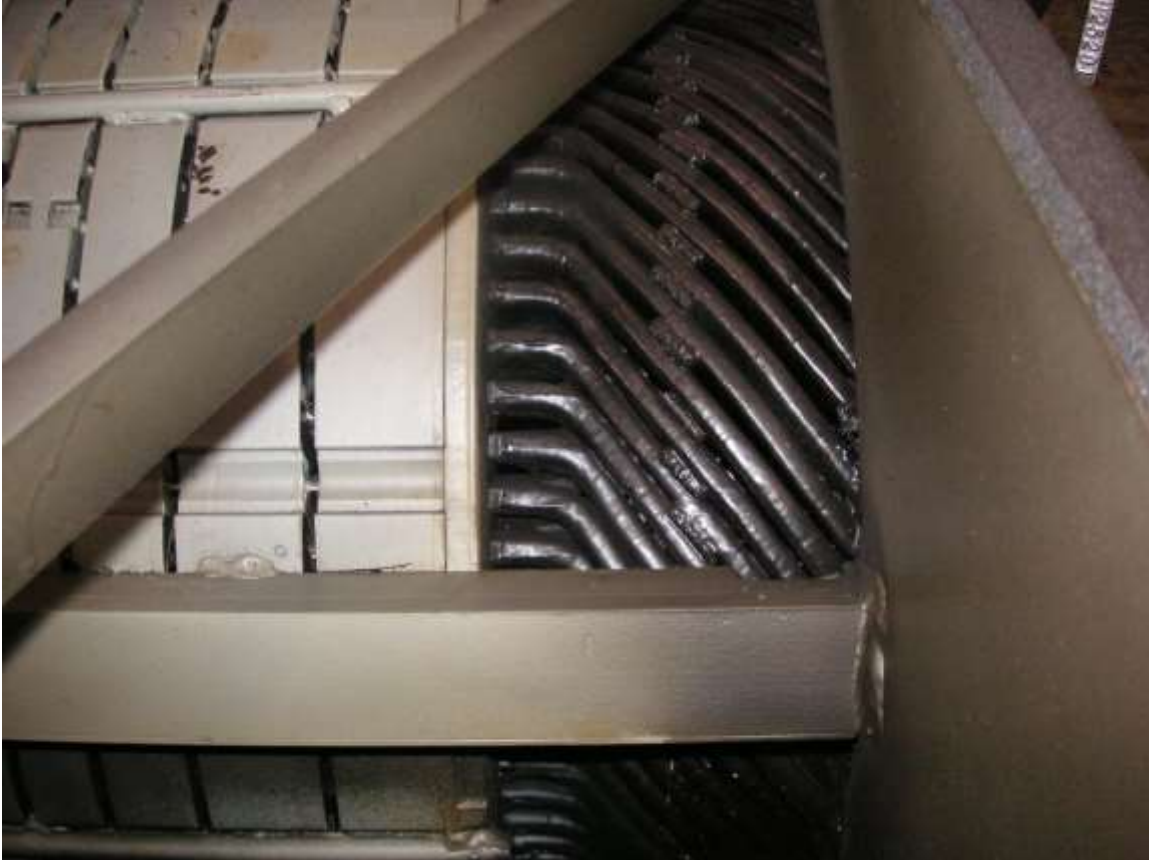
**Figure 3: Louis Allis 800 HP Stator**

Excessive coil movement will cause fractures in the coils as they leave the stator slot. In the case of the 800 horsepower motor, this movement coupled with oil contamination caused the winding to fail where the windings leave the slot.

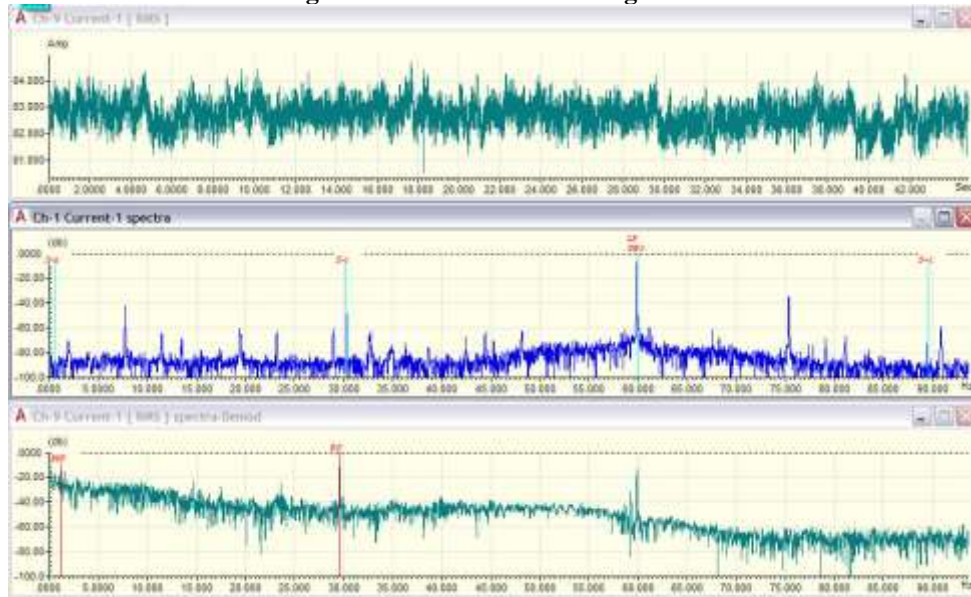
**Figure 5: Unbalance or Misalignment**

One of the most common faults detected using ESA is the 1X RPM signature that relates to unbalance or misalignment. In the case of this signature you can see that the RMS current appears relatively constant while in the lower window there is a definite 1X peak in the demodulated spectra. The middle spectra shows the sidebands around Line Frequency (LF) as S-1 and S+1 which relate as Line Frequency plus and minus running speed. The values are each above -47dB which relates to a severe condition which was misalignment, in this case.

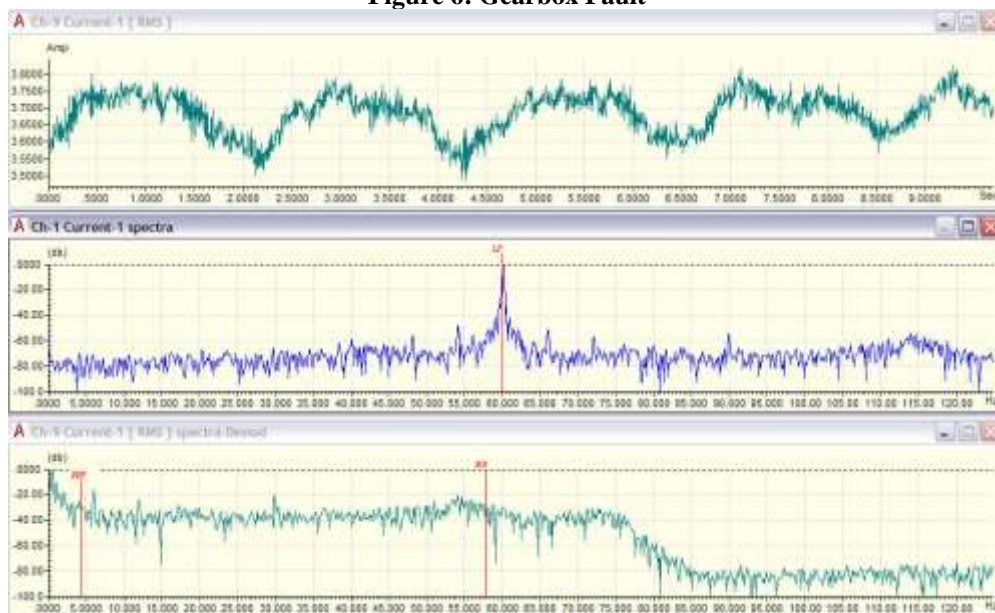
**Figure 6: Gearbox Fault**

Note first the regular variation of the current in the top screen and then the wide base around Line Frequency in the middle spectra. This relates to looseness outside of the motor with few problems identified in the demod spectra. This signature relates to a bad gearbox that required repair.

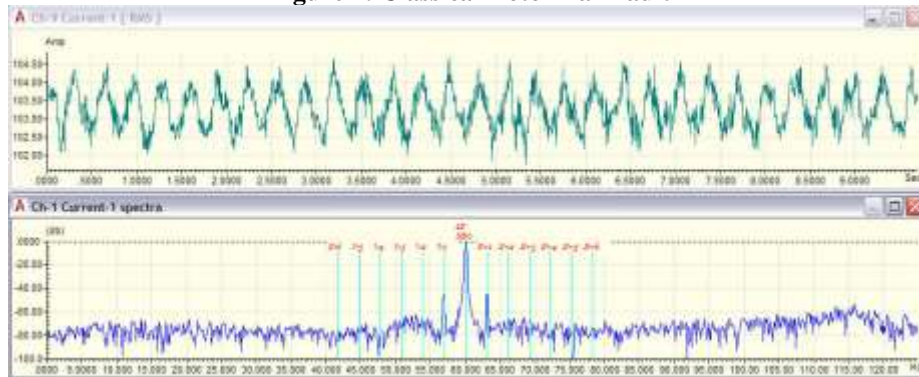
**Figure 7: Classical Rotor Bar Fault**

Broken rotor bars will always appear as two distinct peaks above the noise floor at the pole pass frequency sidebands of line frequency.

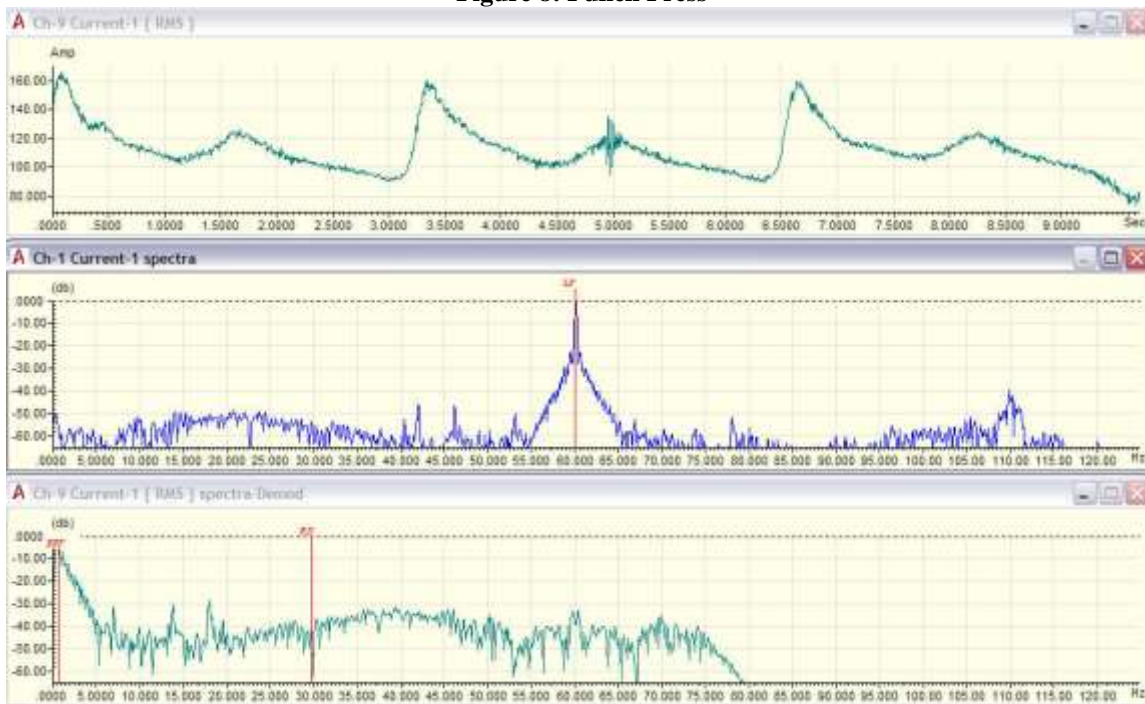
**Figure 8: Punch Press**

As can be seen in this figure, the RMS current fluctuates with the movement of the punch press. Based upon the data, there are three strokes per every ten seconds, resulting in 18 strokes per minute. The broad base around line frequency relates to the operation of the punch press and should be viewed with

caution. If the ESA software automatically alarms for broken rotor bars, this scenario may end up with a false call unless the data is viewed.

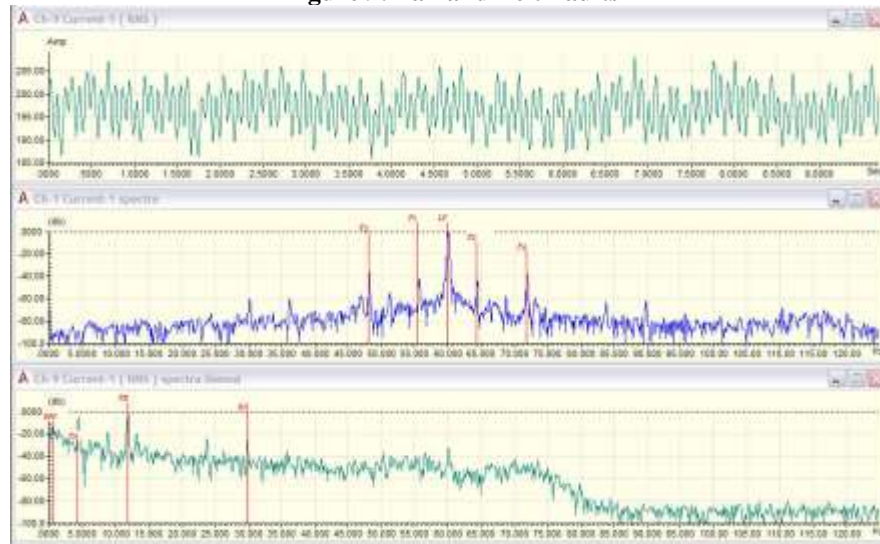
**Figure 9: Fan and Belt Faults**

It is important to know the load that is being evaluated. In this case, the equipment is a fan and the FA peak in demod relates to the sidebands F1 and F2 and the FB peak in demod relates to F3 and F4. These peaks relate to the sheave, belts and fan, and usually indicate misaligned and improperly tensioned belts. The signature can also relate to a problem with the fan. If this had been a pump application, the signature would have related to a bad or cavitating impellor.

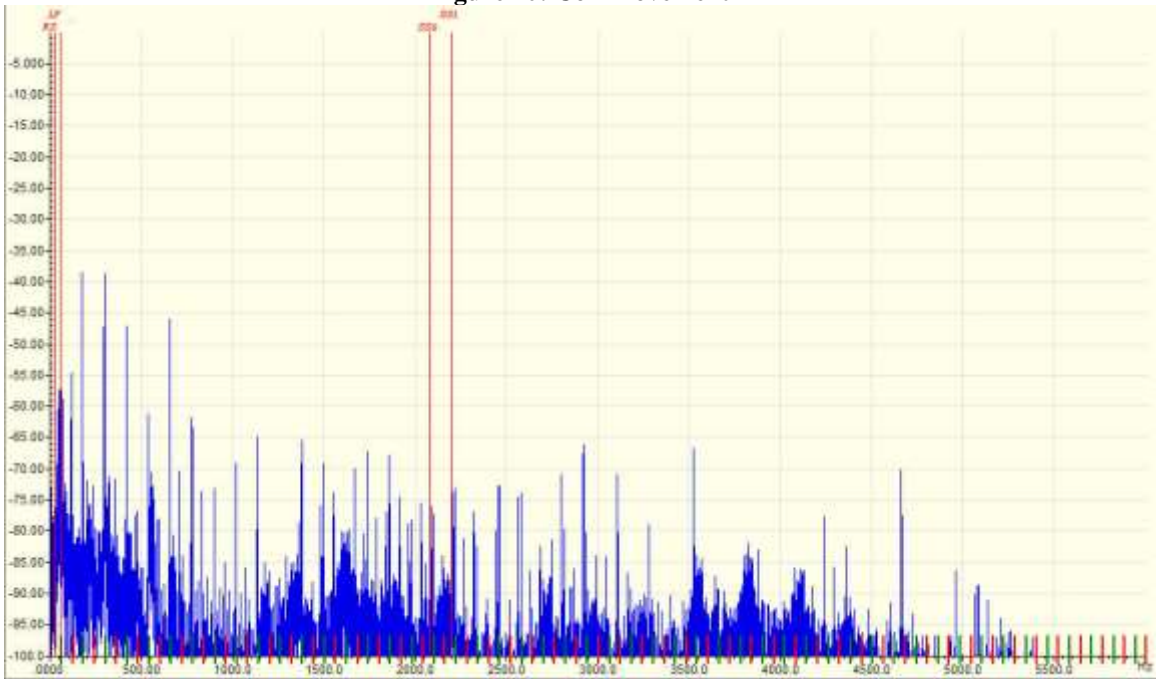
**Figure 10: Coil Movement**

This is one of the cases where knowing the number of stator slots can be very important. Line frequency sidebands of the number of stator slots times the running speed should not exist above the noise floor at all. In this case, all of the motors showing this signature have failed.

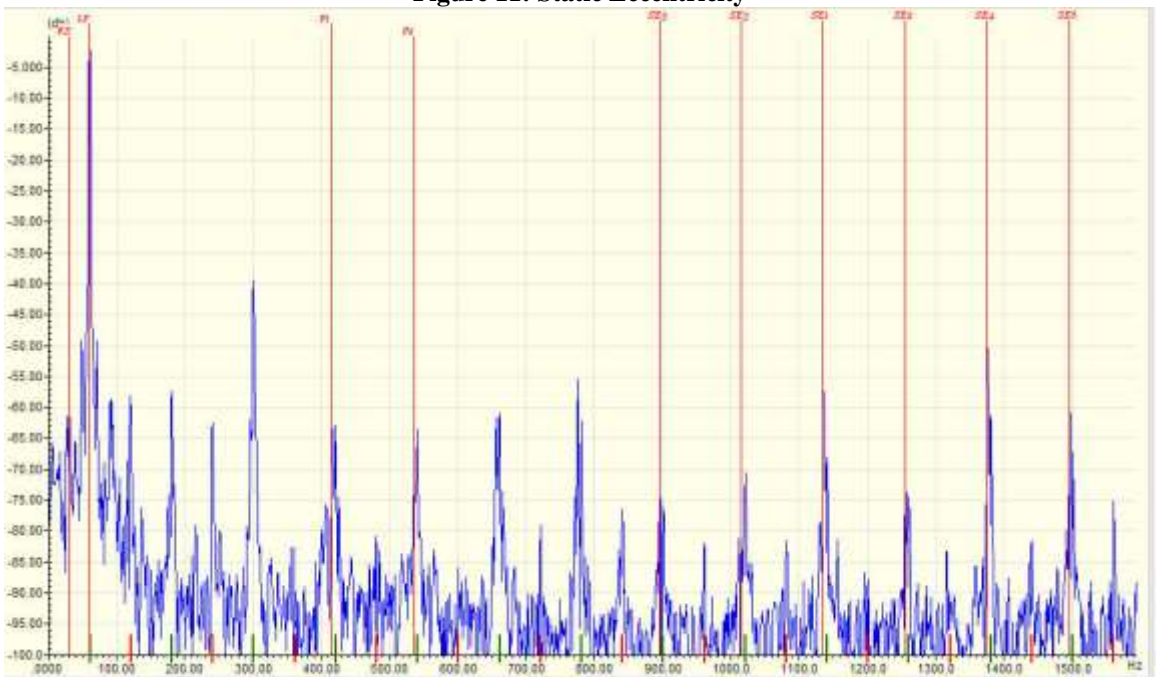
**Figure 11: Static Eccentricity**

This tends to be an uncommon fault. However, these values indicate that the rotor is definitely off center in the motor airgap.

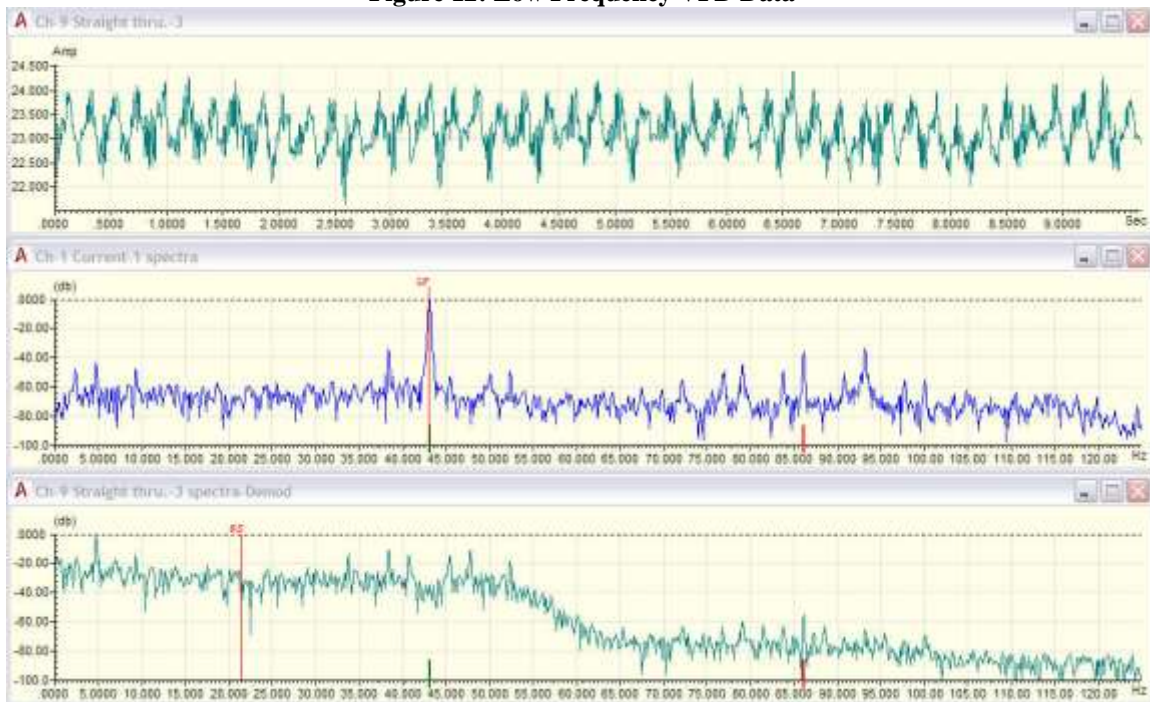
**Figure 12: Low Frequency VFD Data**

As noted in this data, the Line Frequency is about 43 Hz, and the speed has changed appropriately ( $43\text{Hz}/60\text{Hz} \times \text{nameplate RPM}$ ). The first glance at this data does not identify any particular issue with the motor.

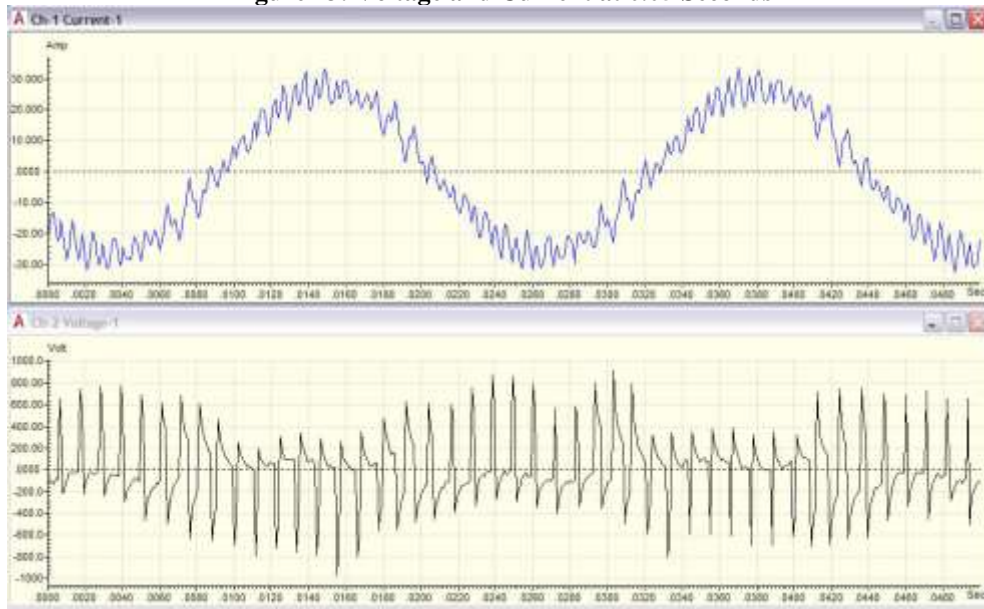
**Figure 13: Voltage and Current at 0.05 Seconds**

Figure 13 shows the voltage and current at 0.05 seconds and Figure 14 shows the floating noise floor that indicates that the ground reference is not correct for the VFD.

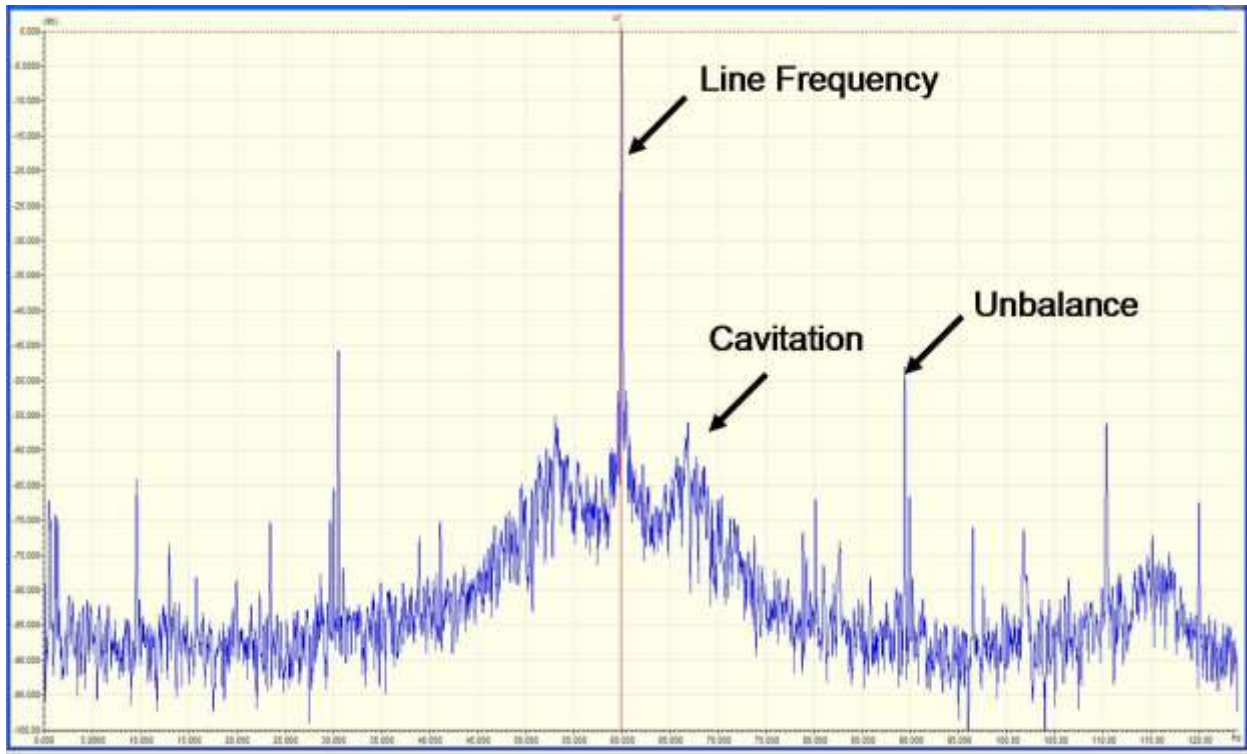
Figure 15: Cavitation Signature Low Frequency Current FFT

As noted in Figure 15, there is a raised noise floor about the impellor signature which allows the analyst to determine the running speed of the motor. Once an analyst has the running speed and has access to information on other components, the analyst can determine if a problem exists.

The reason for this raised noise floor is that cavitation relates directly to the significant energy that occurs as gasses in the fluid being pumped come into contact with surfaces such as the impellor. This represents enough energy to remove small bits of metal from the internal components of the pump as well as damage seal components. As these 'explosions' are random, they result in random vibration peaks that are related to the impellor. On the FFT, these peaks show next to each other which results in the 'raised noise floor,' which actually represents a massive number of signature related peaks.

The 'impellor signature' has been found to reside between 5Hz and 15Hz in virtually all pump applications.
