## **Application of Electrical Signature Analysis**

Howard W Penrose, Ph.D., CMRP  
President, SUCCESS by DESIGN

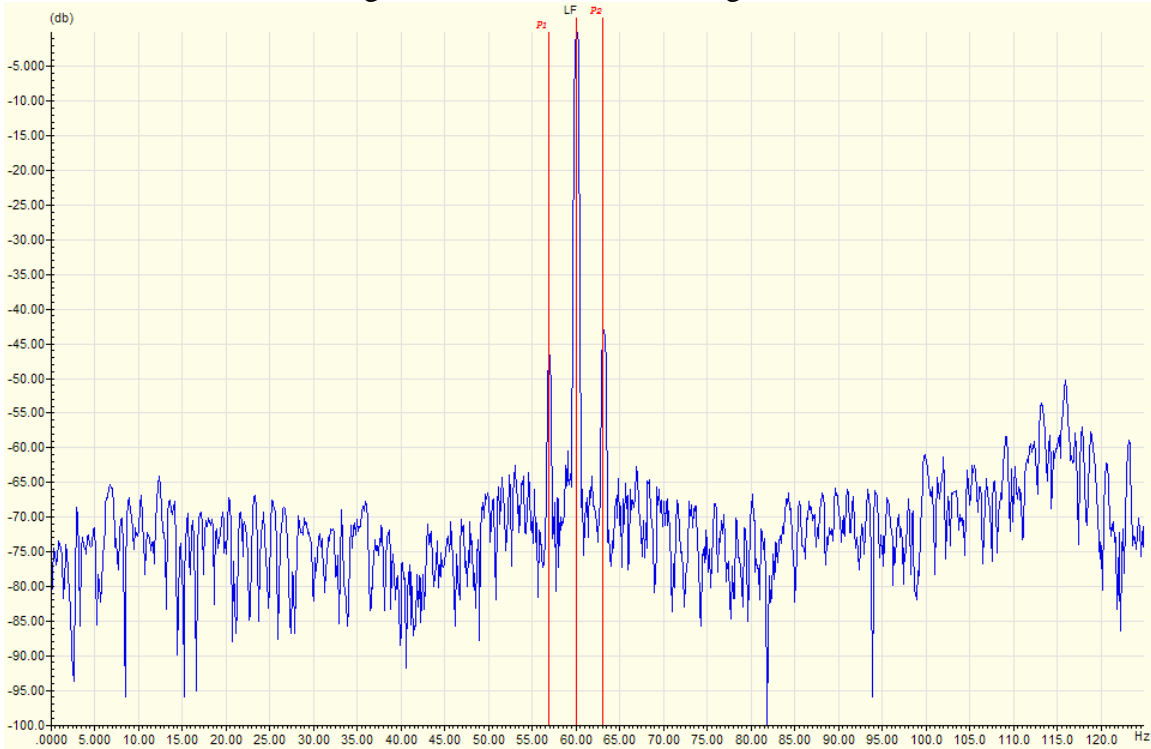
Figure 1: Broken Rotor Bar Signature

When the Pole Pass Frequency sidebands (P1 and P2) of Figure 1 are compared to the values in Table 1, and the condition of the rotor bars can be determined. However, in this case, the motor is 4,160 Vac and the data was taken from the Motor Control Center (MCC) Current Transformers (CT). The result can be a dampening effect on those peaks resulting in the analyst needing to estimate the severity of the fault.

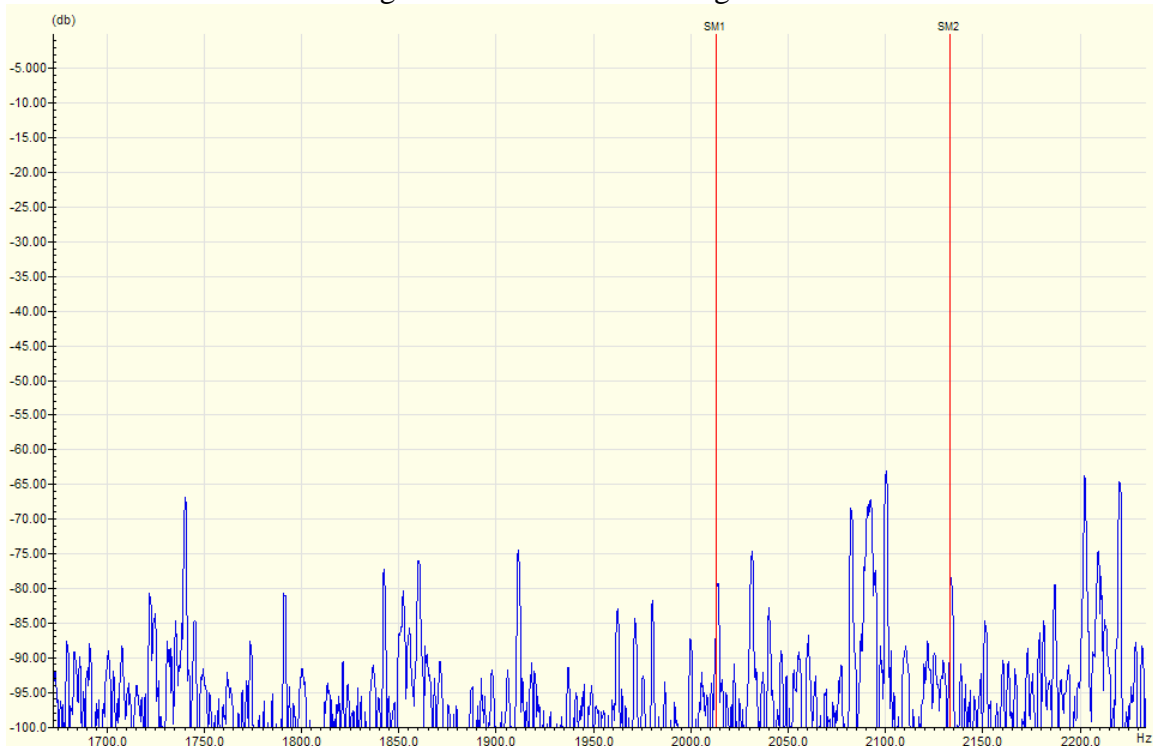
Figure 2: Coil Movement Signature

In figure 2, the motor is an 800 horsepower, 1785 RPM, 101 Amp, Louis Allis motor with 58 rotor bars and 72 stator slots. SM1 and SM2 are peaks related to the movement of the coil ends of the motor windings. As measured through the CT's, the values are about -78 dB which would be more severe if the current was measured directly. With an RPM of 28.793 Hz (1727.6 RPM), the stator mechanical (coil movement) frequencies would be the number of stator slots times the running speed plus and minus the line frequency. In this case, 2013.1 Hz and 2133.1 Hz which relates to the fields passing through the coils ends and interacting with the rotor fields.

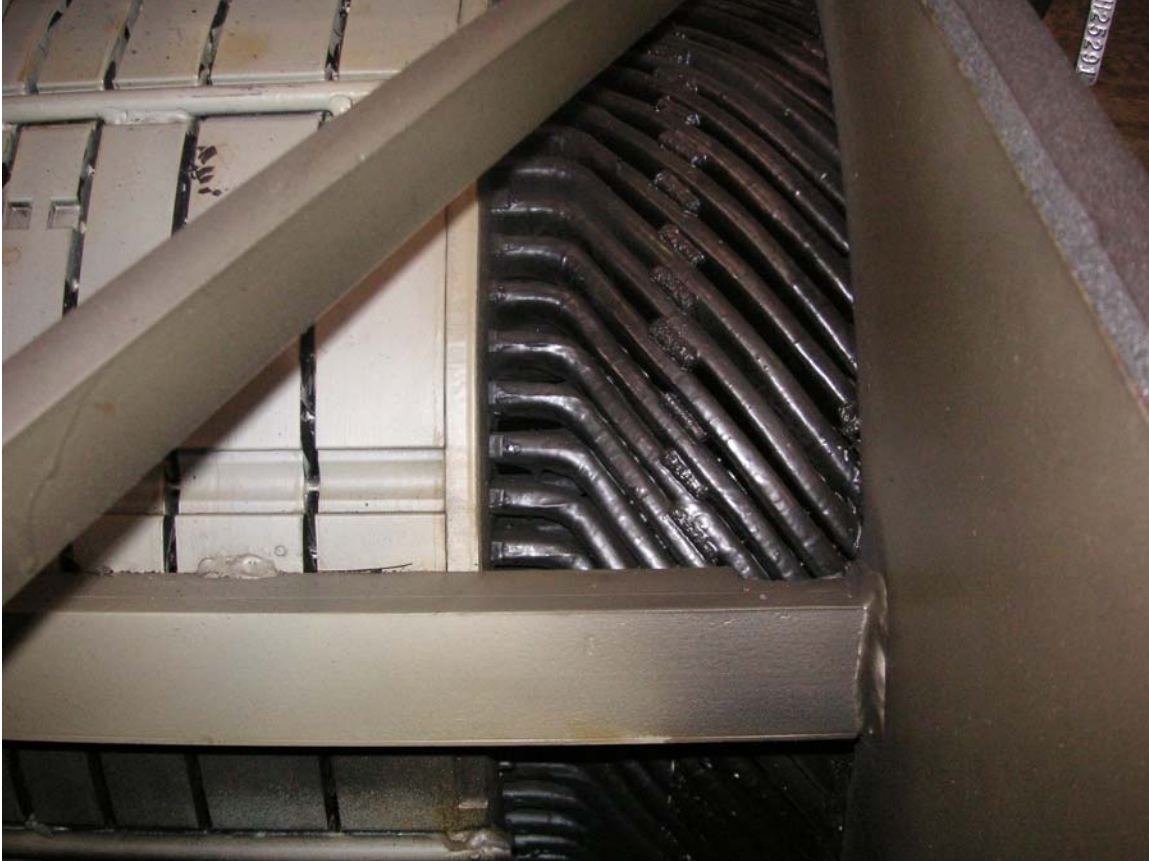
Figure 3: Louis Allis 800 HP Stator

Excessive coil movement will cause fractures in the coils as they leave the stator slot. In the case of the 800 horsepower motor, this movement coupled with oil contamination caused the winding to fail where the windings leave the slot.
