## Case Study 1: ALL-TEST Pro 5 and ALL-TEST Pro OL

Condition: 1250 HP, 690 Vac, Variable Frequency motor random testing with the ALL-TEST Pro 5 dynamic test identified a rotor related problem.

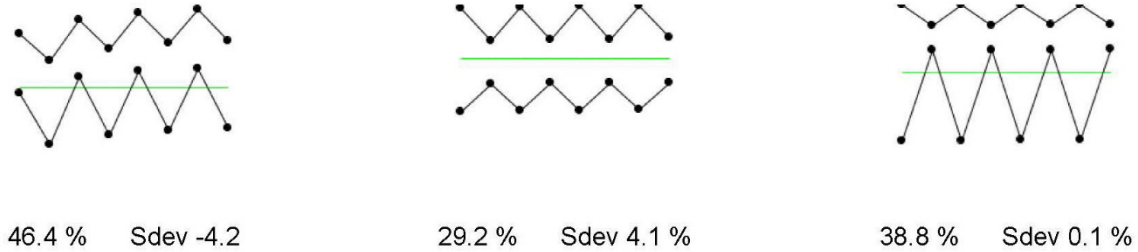
Figure 1: Rotor Inductance in relation to stator Inductance to detect rotor problems

During a MotorDoc LLC Electrical Motor Diagnostics class a 1250 horsepower, 690 Volt motor was randomly tested with the ALL-TEST Pro 5 using the ALL-TEST Pro 33 methodology (see ALL-TEST Pro 5 vs ALL-TEST Pro 33 video at <http://www.motordoc.com>) and in less than a minute the students and instruments had identified that there was a problem with the rotor bars. The following day the motor was connected to a Variable Frequency Drive and brought up to 515 Vac to allow a little slip with the motor unloaded.

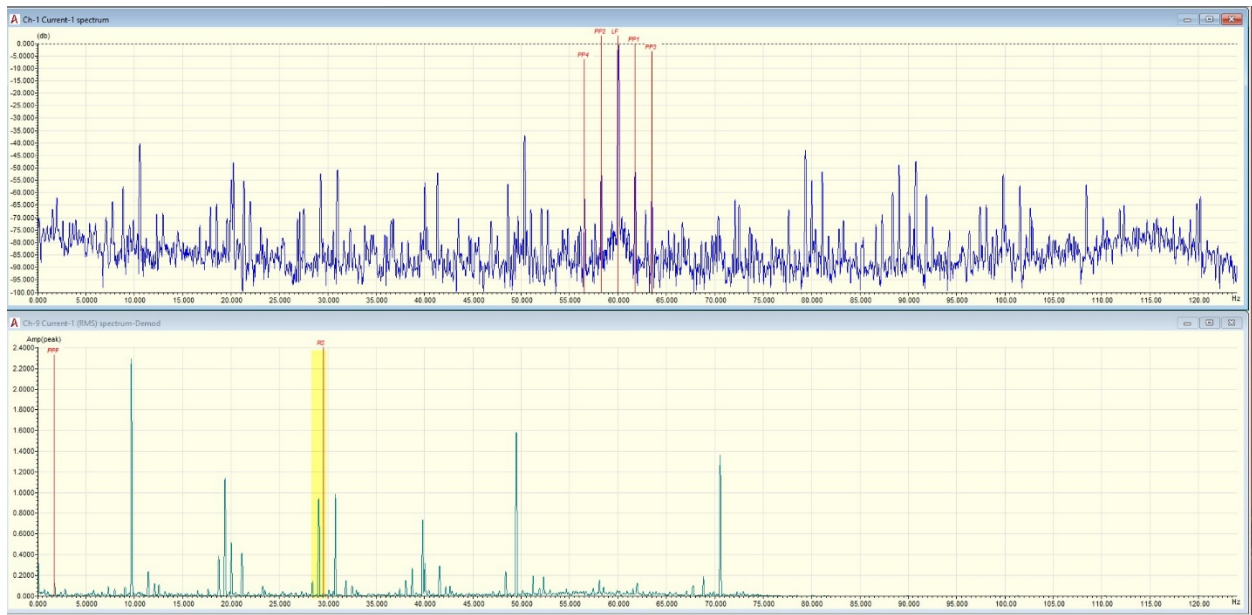
Figure 2: Electrical Signature Analysis indicating rotor problems.

Electrical Signature Analysis using the ALL-TEST Pro OL instrument was performed and sidebands of pole pass frequency were found around the line frequency (Figure 2). This is a clear indicator of problems with the rotor which is aluminum and of new manufacture. This would indicate that there are severe casting voids that may cause some level of electrical vibration or operating torque issues.

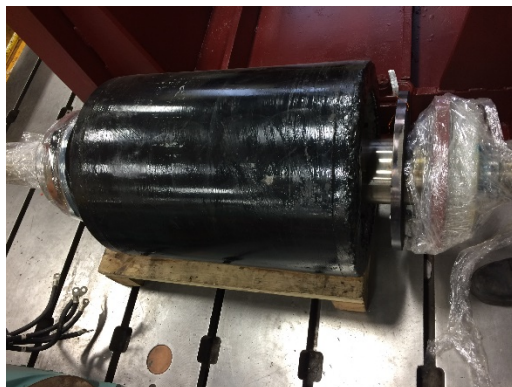
Figure 3: Rotor from 1250 hp Motor

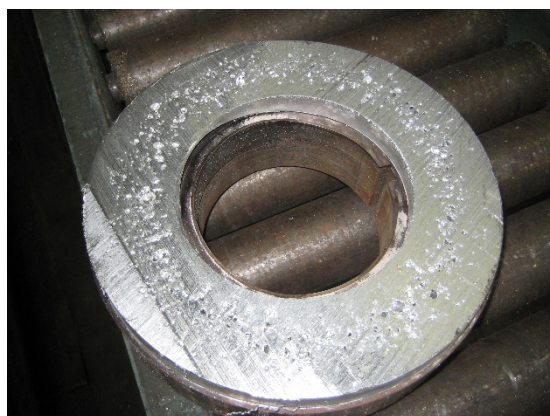
Figure 4 represents the types of casting voids that appear in aluminum cast rotors.

Figure 4: A section of a different cast rotor of similar size
