# ***Evaluating Induction Motor Rotor Bars with Electrical Signature Analysis***

Howard W Penrose, Ph.D., CMRP  
***SUCCESS by DESIGN***  
**Reliability Services**

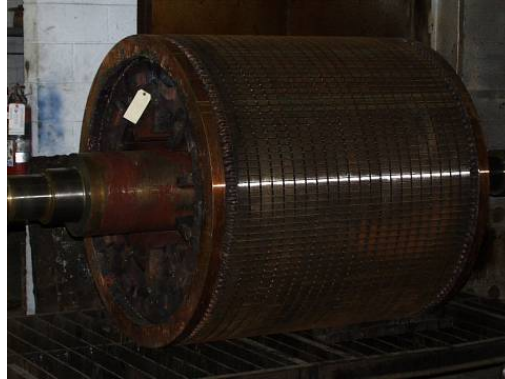
## Thermal Forces

- Each start of the machine
- Saturation as rotor frequency high
- Heat dissipates into rotor
- Excessive starts can cause rotor bar material to become 'brittle.'

Another key force that acts on the rotor bars is thermal force. This involves the temperature of the rotor bars and rotor iron and the effects of each.

Each time a machine is started, the current in the rotor bars has a high frequency and higher impedance. This generates a tremendous amount of heat that is absorbed by both the rotor bars as  $I^2R$  losses and the rotor core, which is magnetically saturated during startup. The longer it takes to come up to speed, the more heat, measured as watts, is generated.

If the rotor bars become too hot, they become more 'brittle' or subject to the variety of forces that are occurring within the rotor, rotor bars and shorting rings, including inertial forces. This is one of the reasons why an electric motor has a limited number of starts. Because larger machines actually have less steel per horsepower, they tend to have fewer allowable starts, plus there is one other force that acts on the larger machines more so than the smaller ones.

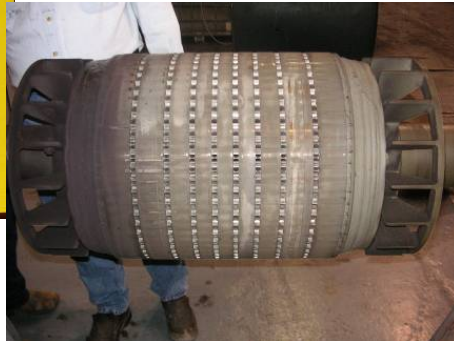
Rotor bar construction – rotor and end rings calcuated as different inertial forces

When looking at cast rotors, such as the one in the picture to the left, when the inertial forces are calculated, they are calculated as one mass because all of the components are in direct contact with each other. Larger machines tend to use copper alloy rotor bars, such as the rotor in the picture on the right. In this case, the shorting rings for the squirrel cage tend to be separate from the rotor core and braized to the rotor bars. The effect is that the rotor core and shorting rings are calculated seperately, in terms of torque, and have different inertial mass. This causes an additional bending stress on the rotor bars as they leave the rotor core and where they attach to the shorting ring. The result is that they tend to break at either point where it is rare to see a cast rotor with broken rotor bars.
