Study of Insulation Resistance Profiling Use on Random and Form Wound Machines Under 6kV

Howard W Penrose, Ph.D., CMRP
Vice President, Engineering and Reliability Programs
Dreisilker Electric Motors, Inc.
Glen Ellyn, Illinois

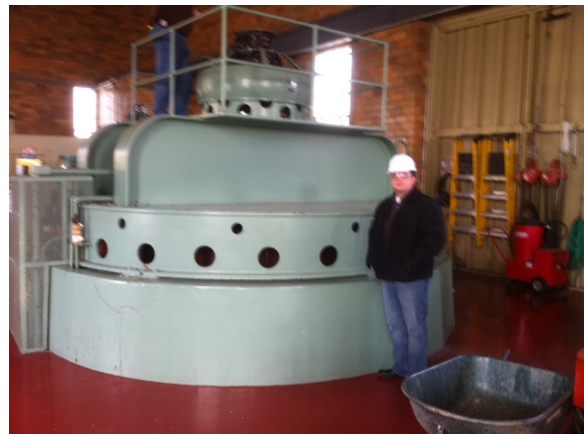
Figure 1. Generator Prior to Disassembly and Testing

The generator being reviewed is a 1935 era General Electric, 900kVA, 4800Vac, 120 RPM hydro generator located at a small dam shown in Fig. 1. IRP testing was performed on both the stator and rotating fields. The rotating fields were tested (Fig. 2) before and after cleaning and lead replacement and the stator was tested before and after a special weeping epoxy was applied then after the epoxy dried.

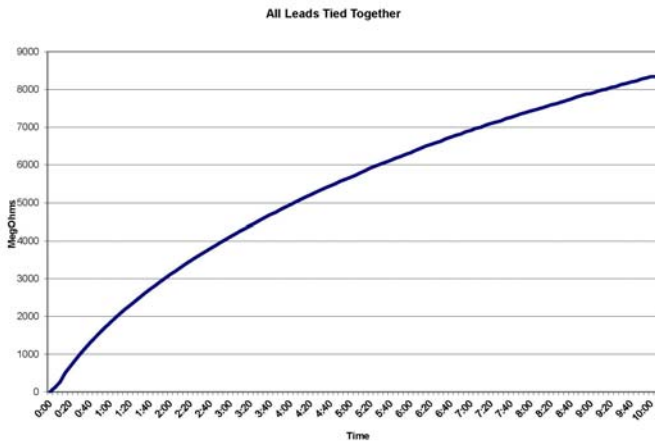
Figure 7. All Leads Tied Together for Testing

Fig. 7 represents the test result from all leads together while Fig. 8 represents all leads tested separately with the other leads grounded. It was immediately noted that there was a difference in the pattern when the phases were tested separately. The drive end cover was removed and a rodent nest was discovered (Fig. 9) that consisted of paper, candy wrappers, and rodent waste on the insulation system. Some chew-marks were discovered in the insulation system but were found to represent only surface marking allowing the stator to be cleaned, dipped in epoxy varnish and returned to service.
