# Evaluation of Offline Partial Discharge in Vacuum Environments

**Abstract**— An evaluation of several insulation types at various degrees of vacuum using repetitive discharge inception and extinction voltage offline testing will be presented. Insulation systems were evaluated in atmosphere and compared to values to 1mmHg using a commercial partial discharge surge tester. The insulation systems evaluated include unvarnished windings, dip and bake epoxy, epoxy trickle impregnation and vacuum encapsulated. The results provide the potential impact of partial discharge with repetitive surges for applications of electric machines in low atmosphere conditions with inverters.

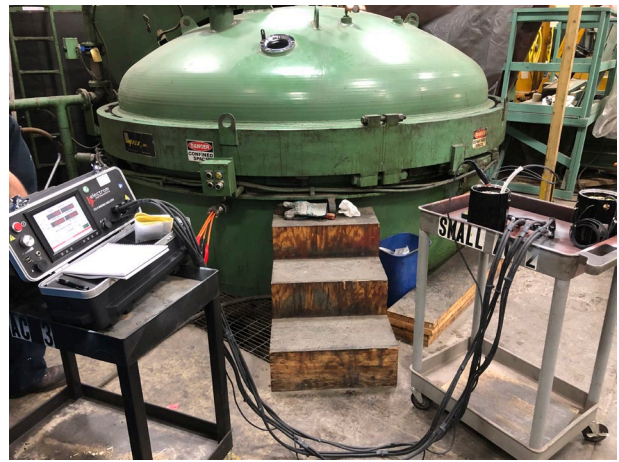
Fig. 1. PD surge tester, VPI tank and two stators being tested in air

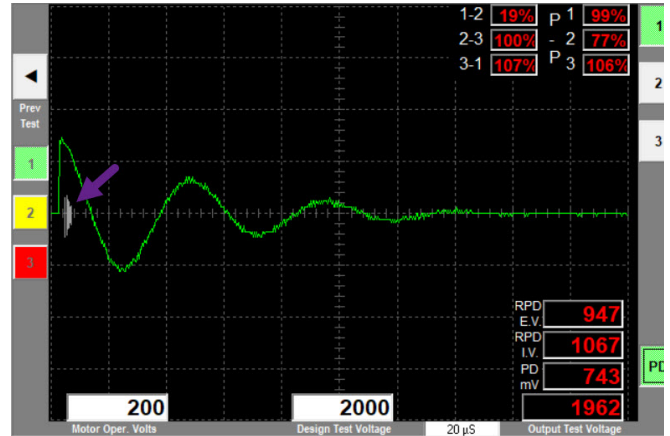
Fig. 3. Example of PD surge display related to arcing

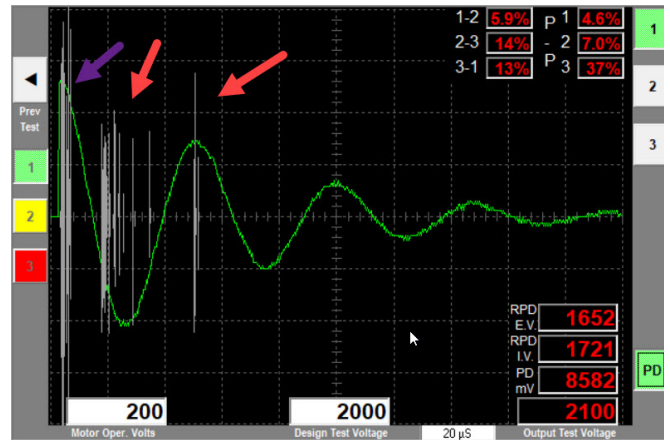
Fig. 4. Example of PD surge display related to partial discharge

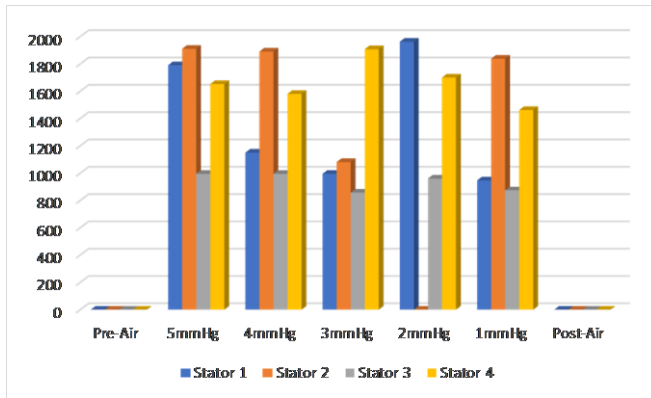
Fig. 6. RPDEV of stators in air and vacuum

As noted in Fig. 5, the RPDIV values are highest, on average, with Stator 4, and one outlier with Stator 2. Stator 3, which was trickle impregnated, had the lowest RPDIV and RPDEV values. Fig. 6 identifies the RPDEV values, which were highest, on average, with Stator 4 with a close high average with Stator 2.

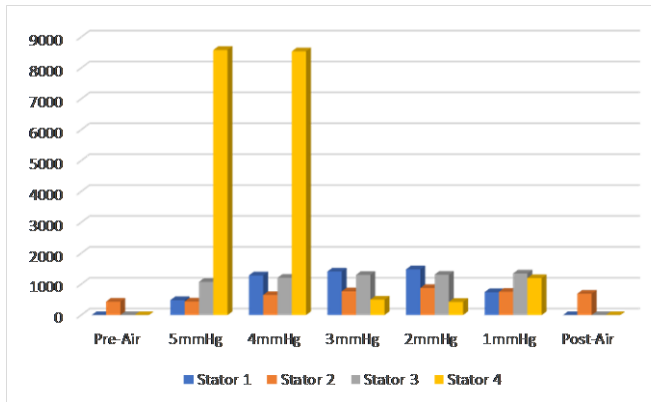
Fig. 7. mV discharge arc and PD of stators in air and vacuum

The discharge values are shown as mV in Fig. 7, which appear higher with Stator 4 at 5mmHg and 4mmHg, then drop to lower than average values during remaining testing. This is most likely due to air in any voids evacuating over time. The more intense discharges were found with Stator 1 and Stator 3 with Stator 2 having the lowest average discharge value.

Stator 4 was the only stator that was identified with winding PD which corresponded to the excessive energy at 5mmHg and 4mmHg. This may represent that the PD that did occur within the windings was energetic due to trapped air around the stator leads. The arcing between connections had lower values with Fig. 9 representing the arcing that occurred between conductors on Stator 4 at 1mmHg.

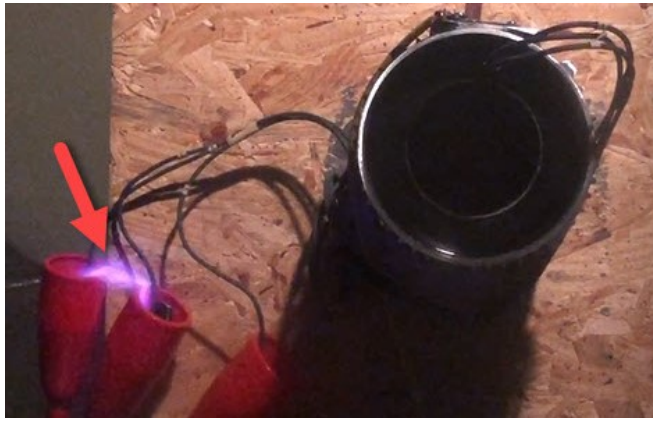
Fig. 9. Arcing at lead connections (purple) due to ionization of remaining gas

Examples of the arcing are found in Fig. 8 and Fig. 9. Fig. 8 relates to arcing that occurs within the stator and back to the leads or to ground, as well as discharges between conductors. Fig. 9 is arcing directly between conductors at the connections to the stator.

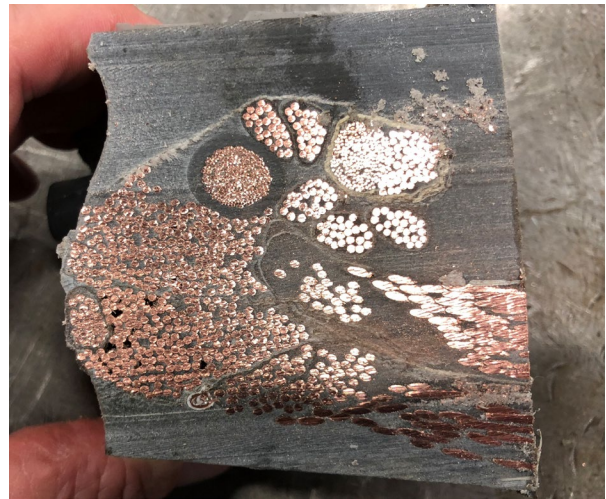
Fig. 10. Vacuum encapsulated stator with voids due to adding material after vacuum encapsulation. Voids progress through stator end with exits by leads.

Stators 1, 2 and 3 windings were directly exposed to vacuum while Stator 4 was sealed with the exception of where the leads enter into the encapsulant. Experience shows in larger stators that vacuum encapsulation can result in small voids on the connection end, which is at the top during the process, as shown in Fig. 10. This would result in air trapped in small voids that can result in high energy discharges between conductors until any remaining air is evacuated, if possible, usually past the leads. In areas where air cannot be bled off in the vacuum environment the electrical stresses will remain high.
