Evaluation of Asynchronous Wind Generator Stator Magnetic Slot Wedge and Coil Movement Using Electrical Signature Analysis

Howard W Penrose, Ph.D., CMRP
 President
 MotorDoc LLC
 Lombard, Illinois, USA
 hpenrose@motordoc.com

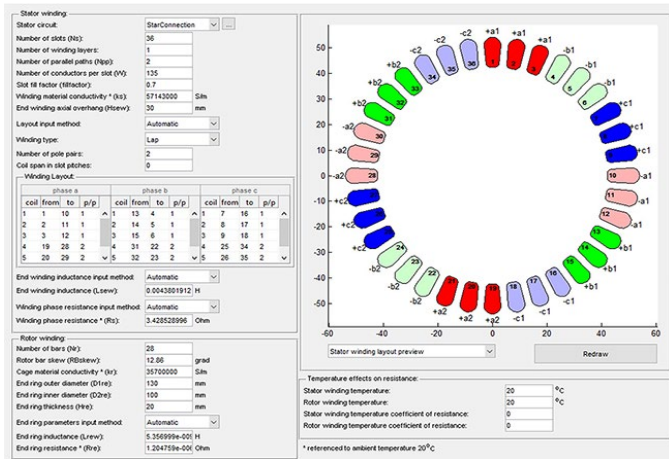
Fig. 1. Finite Element Analysis Model Setup with MotorAnalysis

A Finite Element Analysis (FEA) was performed using a combination of MatLab® and MotorAnalysis® software. The system was selected to analyze both stator windings and rotor construction including materials. It was noted that the system did allow for rotor analysis but was not designed to identify stator related phenomena, requiring some modification to allow for the identification of generic slot defects. This was accomplished by adding and subtracting the number of turns in a single coil to identify how it would affect the machine air gap (Fig. 1).

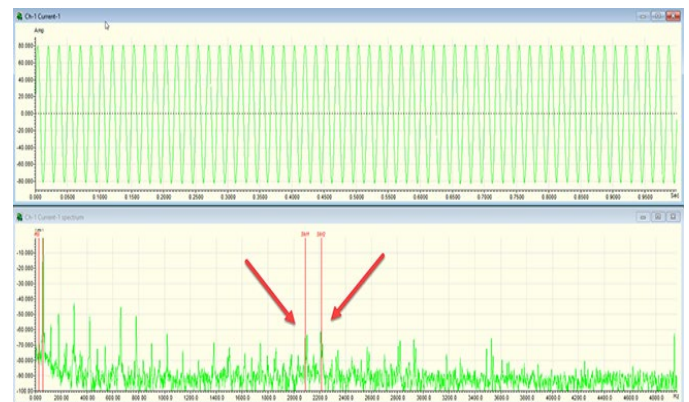
Fig. 4. Wedge signature in an 800 hp induction motor

Prior to the winding failure of an 800-hp, 1785 RPM (29.75 Hz), 4160 Vac motor with 72 stator slots and an ESA-measured running speed of 29.877 Hz (1792.6 RPM) was measured with ESA. The frequencies to be evaluated for stator coil movement

or missing wedges based upon (3) would be 2091.14 Hz and 2211.14 Hz which were identified as shown in Fig. 4.

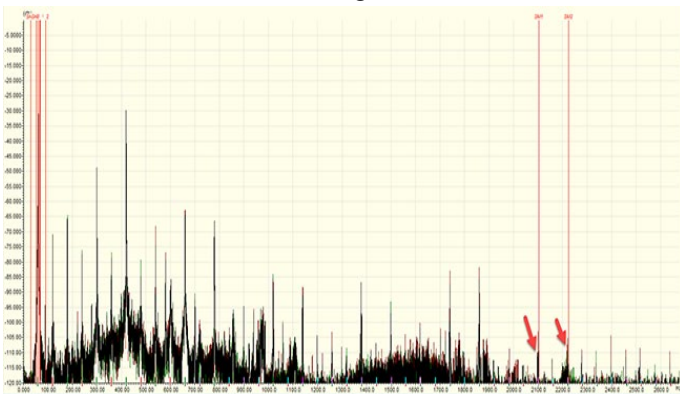
Fig. 6. Wedge signature in DFIG generator with scale in -dB

Prior to removal of a 3MW, 4-pole, Doubly-Fed Inverter Generator (DFIG) operating at 30.224 Hz (1813.44 RPM) an ESA was performed to evaluate detection of known missing magnetic wedges. The signature was found as Fig. 6 with the stator slot signatures at 1572.1 Hz and 1692.1 Hz. Additionally, a winding short signature was found which, as noted in literature, can relate to other conditions such as stator slot sparking. The winding failed to ground prior to removal and was disassembled as shown in Fig. 7.

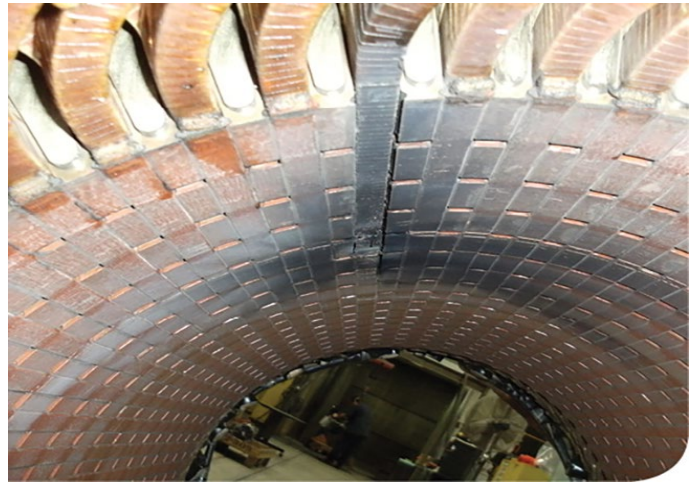
Fig. 7. Stator of DFIG missing wedges and failure point
