Generator REPAIR 101

Finding a failure's real root cause

Why wind generators die young and how to make them work longer

Howard W Penrose

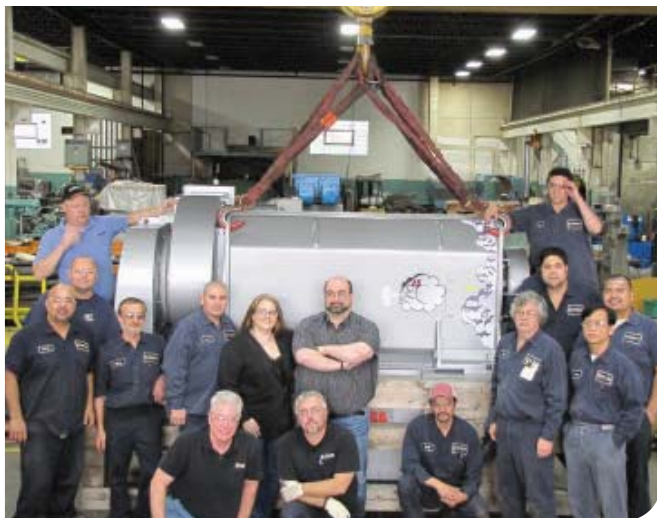
The wind generator is typically located in an area where the ambient temperature is present on all sides with a limited thermal barrier and is not rigidly attached to earth. The generator is quickly loaded when brought on-line resulting in a relatively steep increase in operating temperature. This creates a condition known as thermal shock, a significant change in temperature over a relatively short period. The result of thermal shock is that the stator, coils, and insulating materials start to release from each other due to expansion and impact on the insulating material properties. In effect, the coils begin to loosen. The combination of brittle insulation, followed by softening as the generator comes to temperature, causes compacting of the sponge-like materials underneath the wedges. When the generator is de-energized, depending on the operating environment, it cools quickly with materials contracting at different rates, with the same result of material releasing and compacting.

Eventually, the coils begin to move significantly and radially in the slot (towards and away from the rotor) as each coil magnetically loads and unloads. These forces are significant, if coils have even a relatively small space for movement, forces can be significant and eventually result in ejecting wedges into the air gap. Any small portion of the wedge can rub against the rotor. The material then collects and the iron dust begins to burrow as the coils wear more where the wedges are missing. Eventually, the iron dust provides a path resulting in a coil short where there is significant material at the top of the slot.

The key to resolving this particular failure mode and to extend the life of a generator is to break the chain of events. While the root cause is associated with either design or manufacturing decisions, solutions exist which will not significantly impact the manufacturing cost while designing out a reduced resistance to failure. One method would be to change the wedge material, which eliminates the iron dust and decrease its brittle state. However, it will extend the life only a little because coils will still eject the wedges and then the coil movement will eventually cause failure. The trade-off is the potential de-rating of the generator.
