Infrared Analysis of Electrical Machines and Controls

Howard W Penrose, Ph.D., CMRP
Vice President, Engineering and Reliability Services
Dreisilker Electric Motors, Inc.

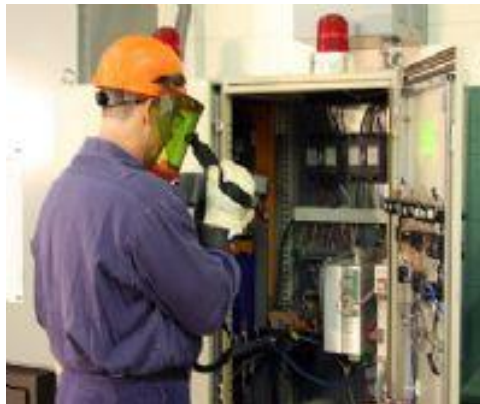
Figure 1: Infrared Thermographer Working with Open Cabinet

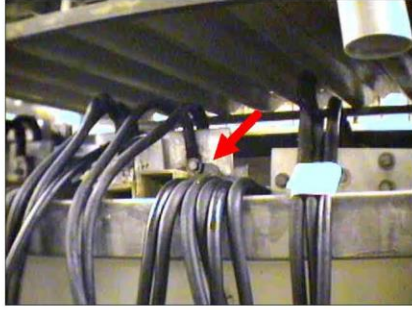
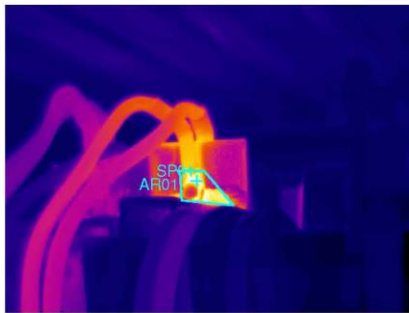
Section	Line #3
Equipment	Annodizer Buss
Additional information	Top
Date	4/3/2007
Time	9:11:25 AM

Fault	#4 Connection
Object parameter	Value
Emissivity	0.98
Object distance	6.0 ft
Label	Value
SP01	166.9°C
AR01 : max	166.9°C
AR01 : max-min	119.9°C

Figure 2: Evaluation of a Loose Bus Connection

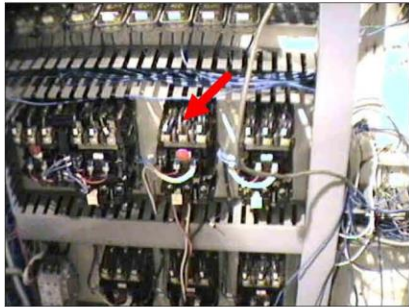
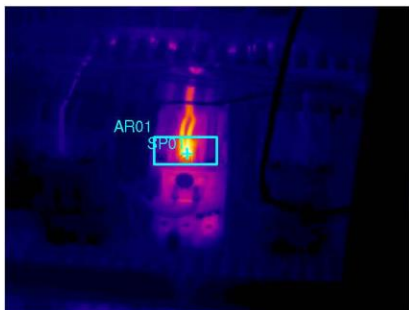
Section	Production Floor
Equipment	Machine #47
Additional information	Control Panel
Date	5/10/2005
Time	8:52:37 AM

Fault	Contactors B Phase
Object parameter	Value
Emissivity	0.96
Object distance	6.0 ft
Label	Value
SP01	126.4°C
AR01 : max	126.4°C
AR01 : max-min	90.1°C

Figure 3: Overloaded Phase in Machine Contactor

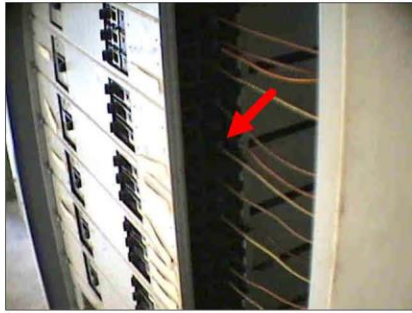
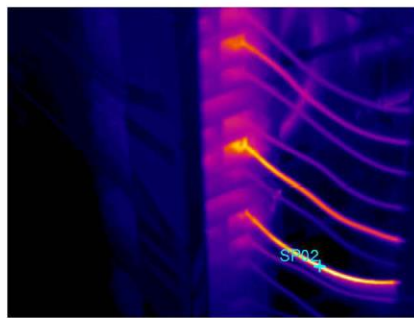
Section	Production Floor
Equipment	MDP-800
Additional information	Warehouse Lites
Date	5/10/2005
Time	7:25:17 AM

Fault	B Phase
Object parameter	Value
Emissivity	0.96
Object distance	6.0 ft
Label	Value
SP02	138.2°C

Figure 4: Loose Connection on Circuit Breaker for Lights

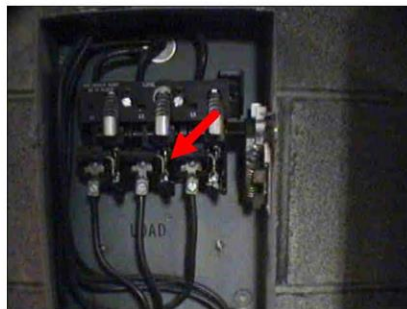
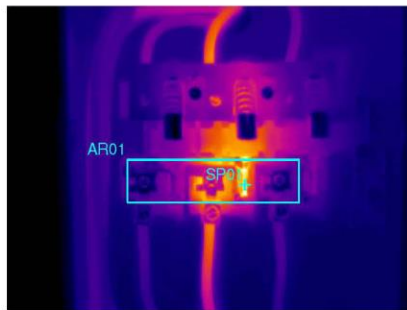
Section	42nd Floor
Equipment	#2 Elevator
Additional information	Disconnect
Date	7/15/2008
Time	9:18:54 AM

Fault	B Phase
Object parameter	Value
Emissivity	0.96
Object distance	6.0 ft
Ambient temperature	24.3°C
Label	Value
SP01	103.6°C
AR01 : max	103.6°C
AR01 : max-min	65.8°C

Figure 5: Loose Connection on Switch for Elevator

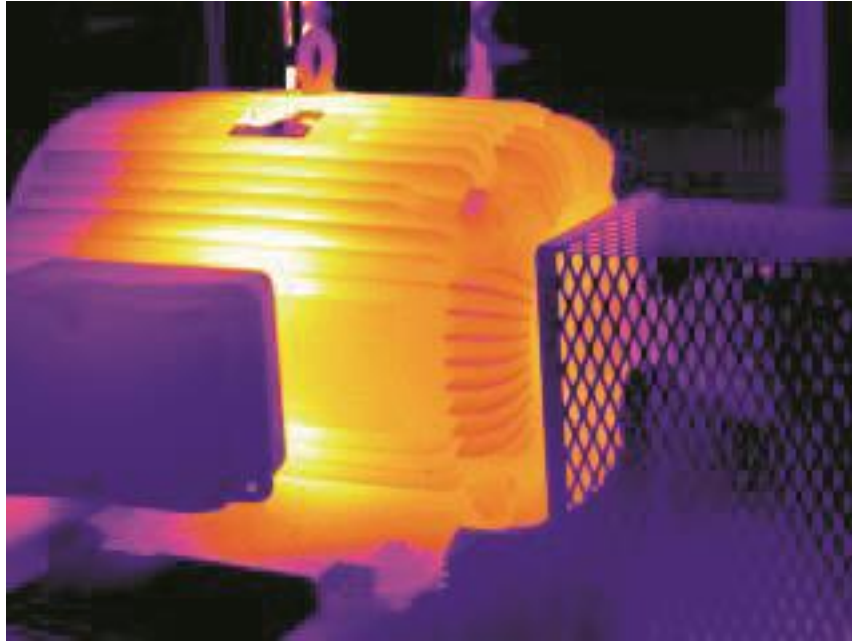
Figure 6: General Infrared Picture of a Motor

In Figure 6, an operating motor has been evaluated. What does this picture show? The motor is a TEFC (Totally Enclosed Fan Cooled) machine which results in the cooler end on the far left. The 'white,' which would indicate 'hot,' is towards the center of the motor. The orange color throughout the rest of the motor indicates heat. The white is where the motor core is located and the differences in color relate to both the angle of the imager and an area made up of air (an excellent thermal insulator) by the connection box. In effect, there is nothing wrong with this particular motor other than infrared thermography generating a colorful picture.

Bearing and coupling issues do stand out and can be quickly identified. Noting also in Figure 6, the coupling to the right and the shaft appear relatively 'cool' compared to the rest of the motor. The coupling should be very close to ambient temperature. The shaft will be warmer close to the motor and cool as it approaches the coupling.

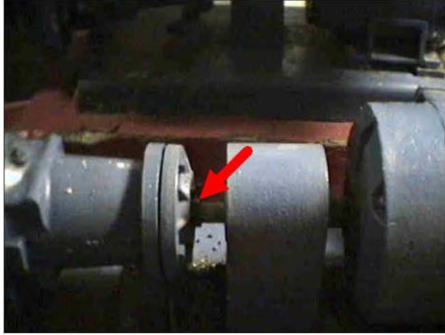
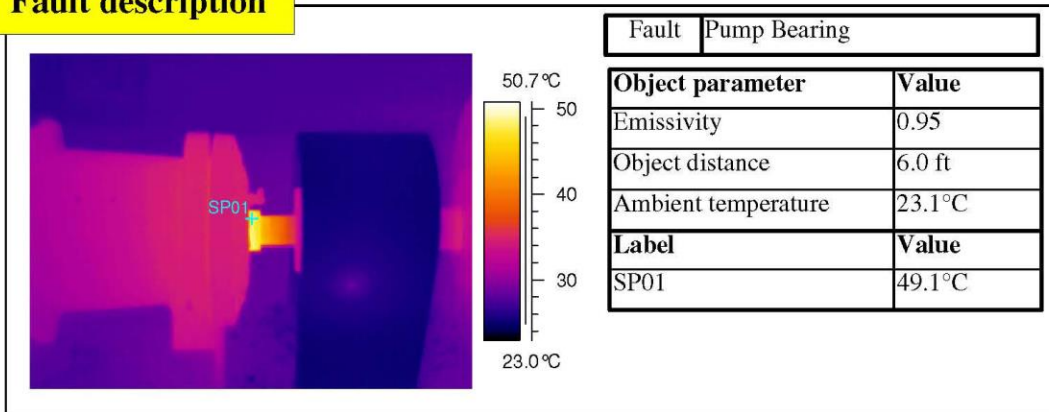
Section	Penthouse
Equipment	Hot Water Pump
Additional information	Mtr & Pmp
Date	10/14/2008
Time	10:21:04 AM

Figure 7: Pump Shaft

As shown in Figure 7, the ability to look at bearings and couplings is not limited to the electric motor but can also be performed for bearings and mechanical components on other rotating machines. It is important to understand the application and if there are contact lip seals in the application.

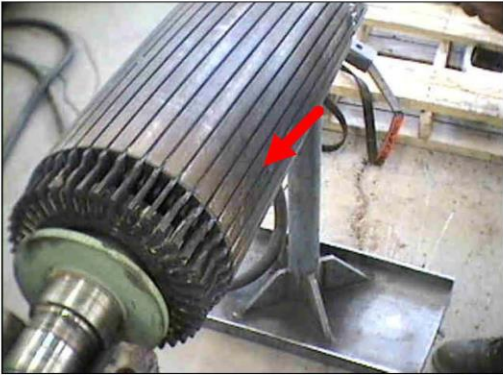
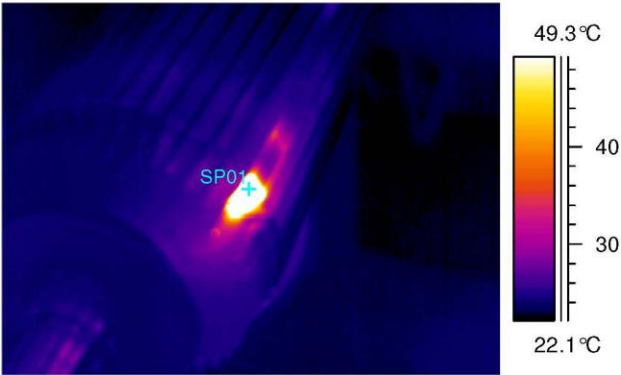
Label	Value
SP01	>223.4°C

Figure 8: Broken Rotor Bar Note Spot Temperature is Greater than 223°C.

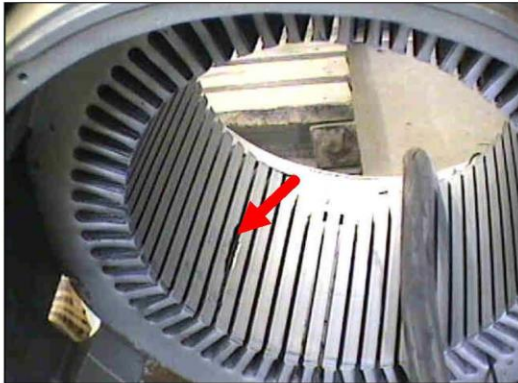
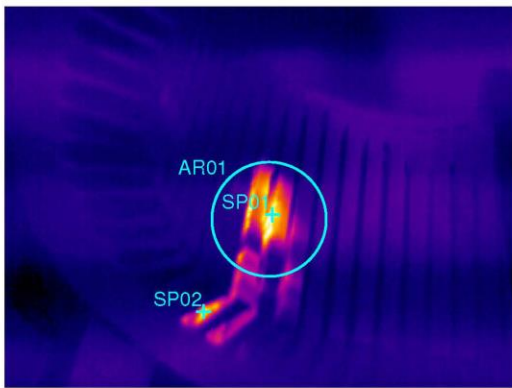
Section	Borg Warner
Equipment	200hp Stator
Additional information	O326739
Date	8/15/2013
Time	9:34:12 AM

Object parameter	Value
Emissivity	0.96
Object distance	6.0 ft
Label	Value
SP02	35.7°C
SP01	37.0°C
AR01 : max	37.3°C
AR01 : max-min	16.3°C

Figure 9: Stator Core Testing

As noted in the top picture of Figure 9, there is obvious core damage. The core loss test, itself, identifies if this raises the overall core losses. The hot spot test is then used to determine if there will be a spot that will cause the insulation to rapidly age thermally. When core problems are identified, just as with the rotor, if temperatures drop rapidly, it may be a simple fix, if they drop slowly, then they tend to be a far deeper issue. Repairs are performed as follow:

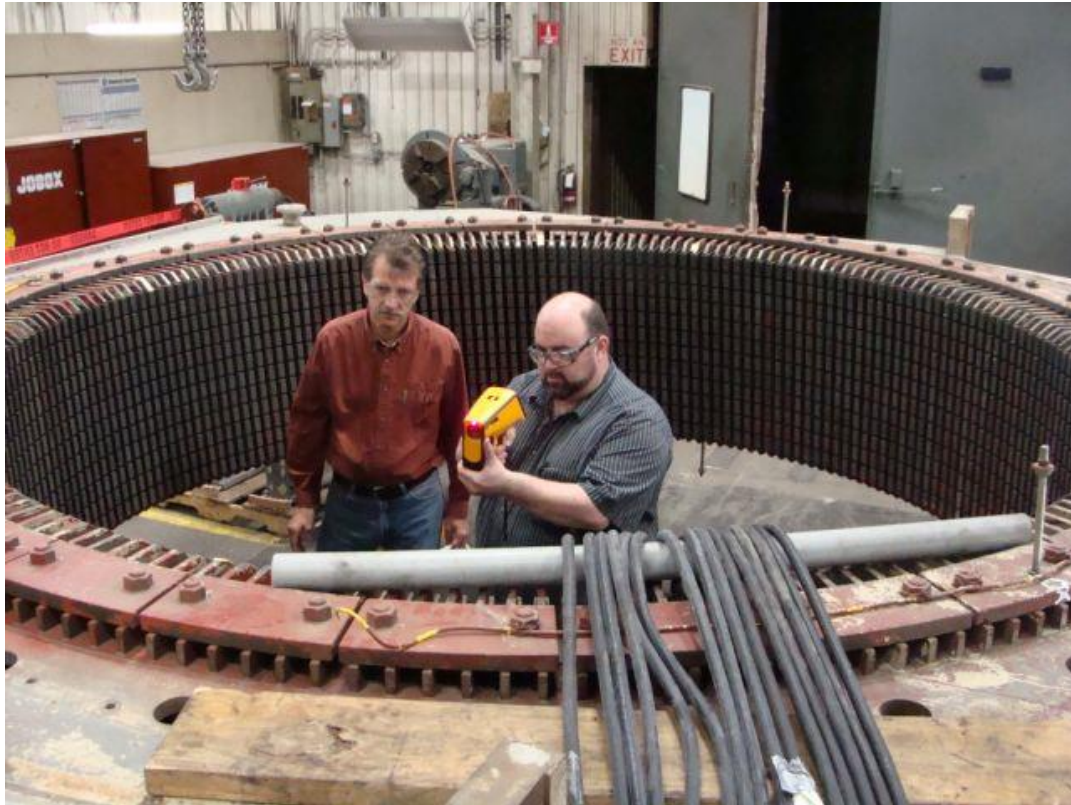
Figure 10: Thermography Performed to Find Shorted Laminations on a Large Stator
