FORENSIC ANALYSIS OF ELECTRIC MACHINES

Case 1: Wind Generator Insulation Systems

Case 2: Breaking Shafts on Variable Frequency Drive Application

Case 3: Lubrication Issue from Leaking Seals

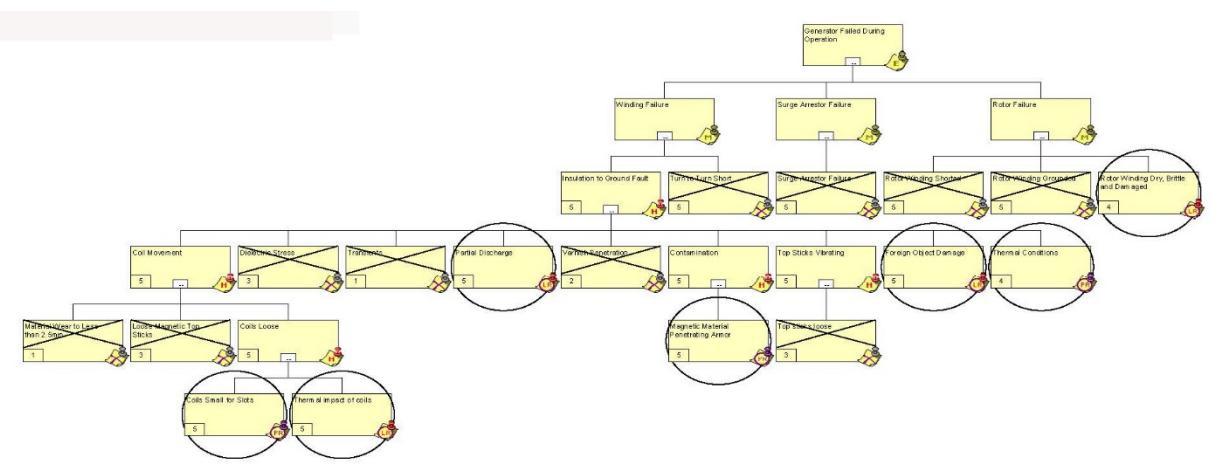
Figure 1: Failure Analysis of Wind Generator

The investigation was initiated because generator insulation systems were failing at an alarming rate across several wind farms on machines that had been in place less than five years. The high failure rate was partially hidden in the past because of an even higher rate of failure of the wind turbine blades and gearbox bearings. While the blades continue to have a high failure rate due to environmental conditions, the chain of bearing failures in the gearboxes significantly changed.

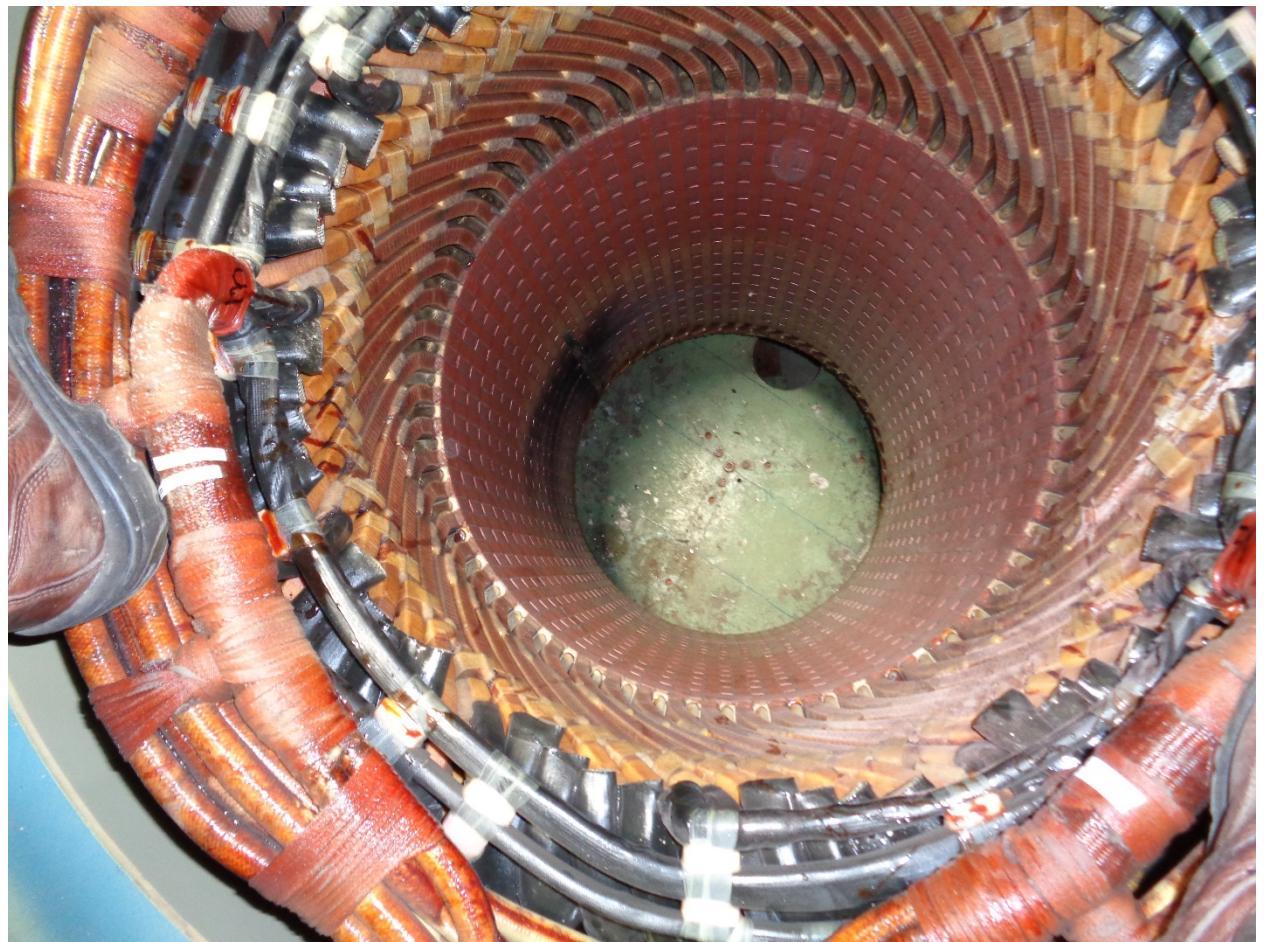
A series of inspections on machine failures by repair organizations noted that magnetic wedges had been ejected into the air gap of the machines. This caused the organizations to publish information related to magnetic wedge failure; that the loose wedges somehow became jammed into the insulation system or were vibrating against the insulation system until it failed. Overall, this did not seem to make sense as some machine designs had this issue while others, also with magnetic wedges, did not fail within the same time period.

Figure 2: Failed Generator Winding

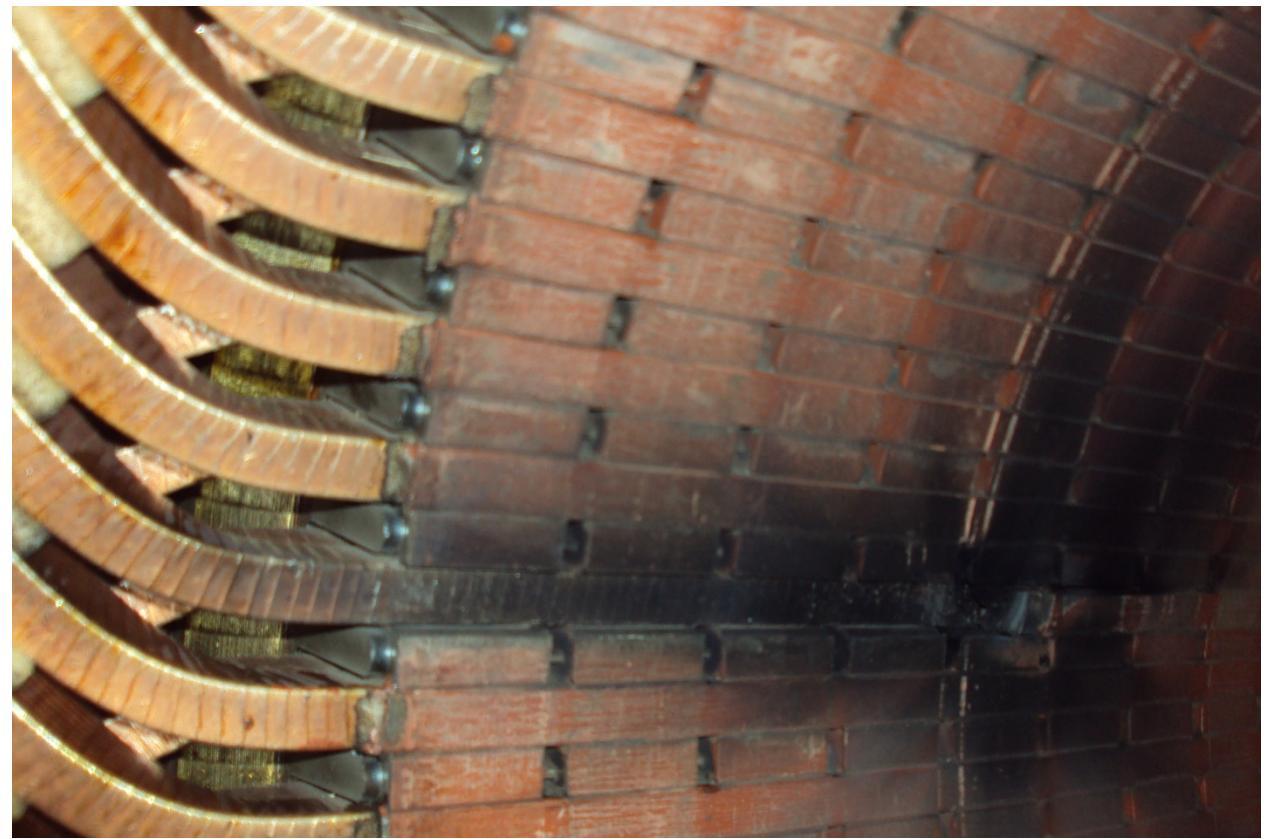
The initial hypothesis was investigated from the time the machine was received through disassembly. As part of this, the machine was stripped using a special low temperature stripping process that allowed investigators to remove intact insulation systems. The first thing that was noted was that the coils in the stator were relatively loose and significant abrasion had occurred. Samples of the coils from the stator were taken from around the failed area as well as areas that were in good condition, investigated by peeling back the layers, and evaluated using a small handheld digital microscope.

Figure 3: Missing Wedge in Generator Winding

As the analysis and evaluation of hypothesis progressed, it was noted that the coils were smaller than standard size for the slots. This was due to a combination of two factors: the coils had been made undersized, and insulation material shrinkage. The coils were being held in place by epoxy varnish, which had released the coils due to thermal shock (significant and constantly changing temperatures). All of the failures were found to have occurred at the top edge of the coil where there was no wedge, and in the direction of rotation. In the area that had not failed to ground, there was magnetic material which appeared to be iron dust from the magnetic wedges.

There were also other defects in the materials that allowed for movement, including the use of low grade insulating materials and the compactable packing materials under the wedges. This is of concern because, while the generator is operating, the coils move radially in towards and out away from the rotor at twice line frequency as the fields expand and collapse. The force varies based upon the loading of the generator.

The result of the findings and confirmation was to look at methods of tightening the coils in the slot. For coils with thicker walls, fewer tape layers would be used and ripple springs would be installed. The ripple springs would allow expansion and contraction of materials without allowing loosening of the coils. In other cases, the coils are made tighter in the slots. Tighter and stiffer materials are used and the varnishing method uses a thicker VPI varnish.

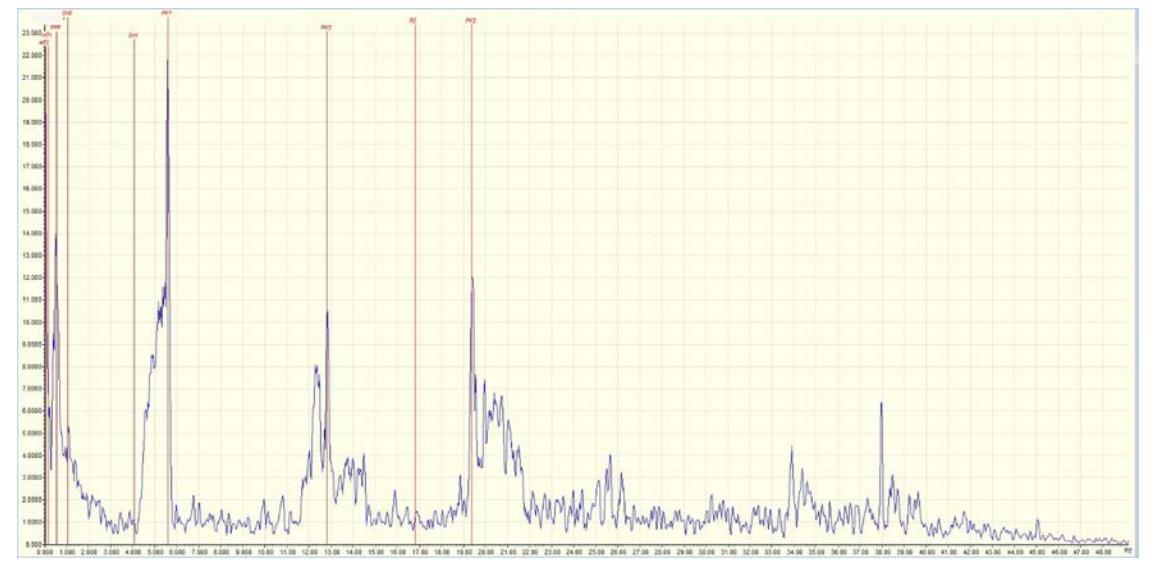
Field testing with Electrical Signature Analysis verified that the coils are moving during operation. The problem was identified, and removal and inspection of the generator confirmed the finding.

Figure 4: ESA Analysis of Generator in Place

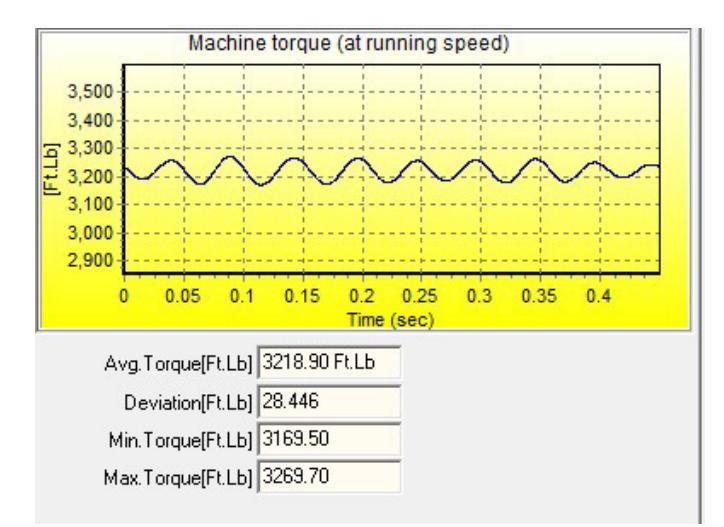
Figure 5: Torque Ripple of Generator in Operation

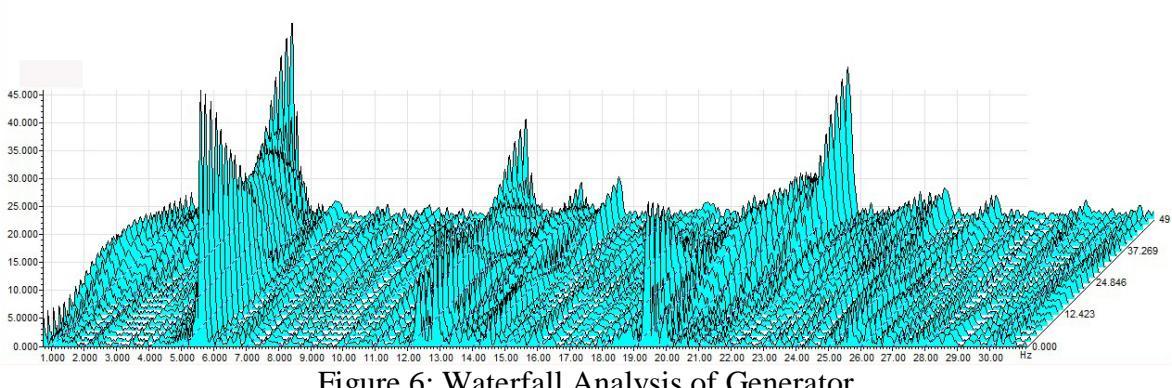
Figure 6: Waterfall Analysis of Generator

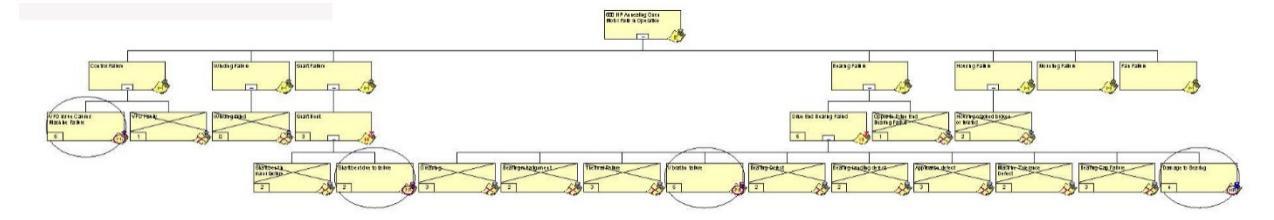
Multiple motors failed in an application with a shaft mounted fan and variable frequency drive. Differences of opinion occurred early on, which resulted in changing out multiple motors of different sizes, altering the operation of the machine, and providing misleading and incorrect information between organizations. In fact, the variety of companies involved were deliberately segregated and prevented from communicating. The problem of shaft breakage and catastrophic equipment failure proceeded through three 800 horsepower, 3600 RPM and 600 horsepower, 3600 RPM electric motors with varying loads and speeds.

Figure 7: Failure Analysis of VFD Motor

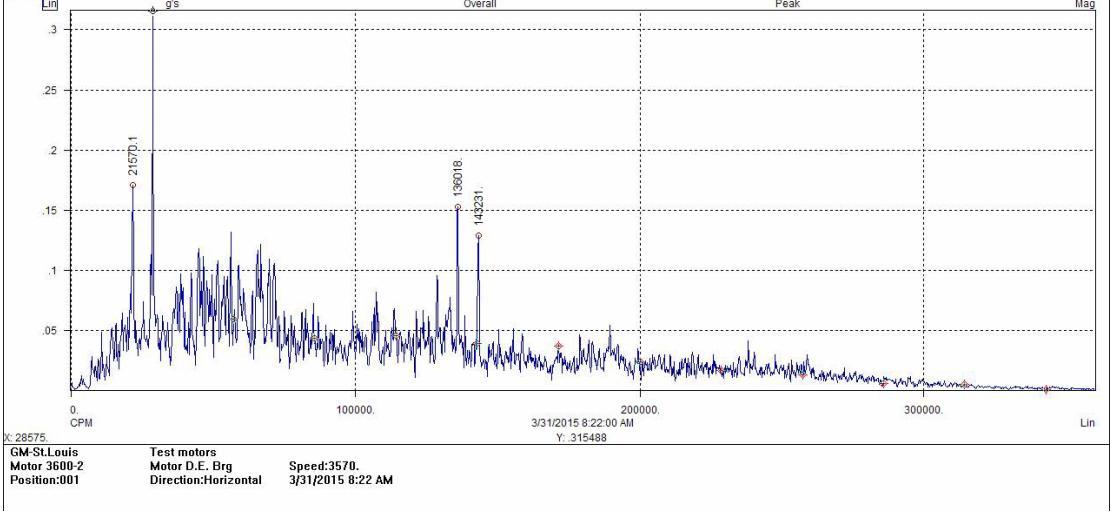
Figure 8: Vibration Signature in Acceleration

During the analysis a number of questions were asked and compared to previous written and emailed responses and reports. Key was the very original request by a field vibration analyst who noted that specific vibration signatures he related to VFD application in acceleration were excessive and he had asked if the drive had been auto-tuned to the motor.

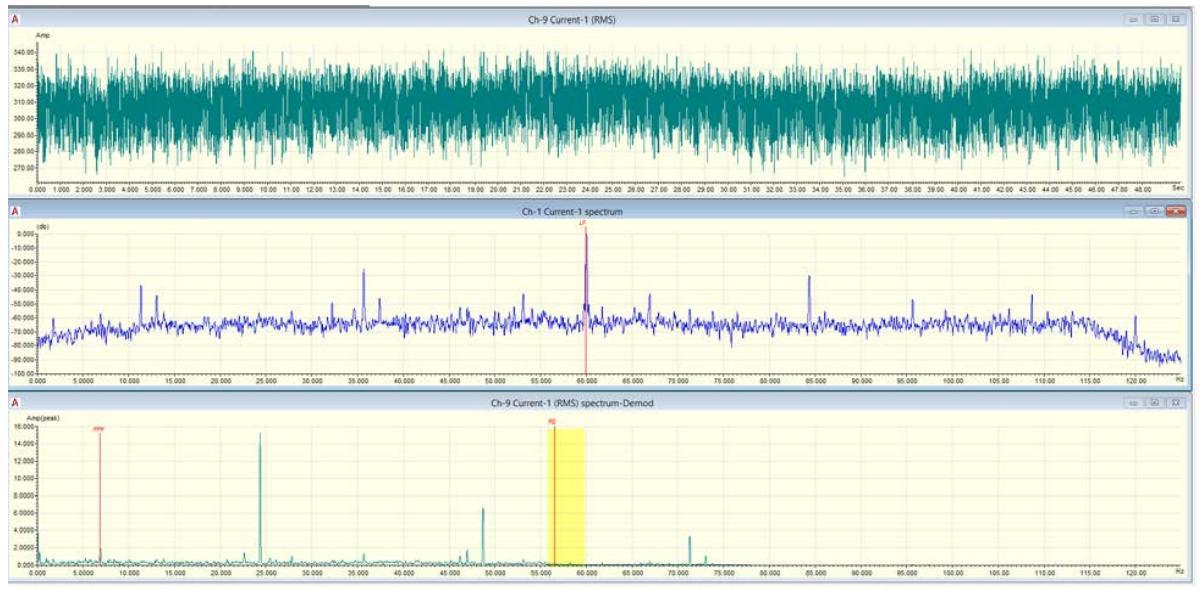
Figure 9: ESA of Torque Ripple

Before confirmation data could be taken with ESA, the equipment was auto-tuned. Afterwards, the ESA torque ripple data was taken and found to still be high, and directly related to the information detected with vibration.

The result of the findings was that instructions were put in place by the end user, manufacturer, and other participants to ensure that auto-tuning would be performed in the future. Additionally, it was determined that the application of ESA would be utilized earlier during failure analysis.

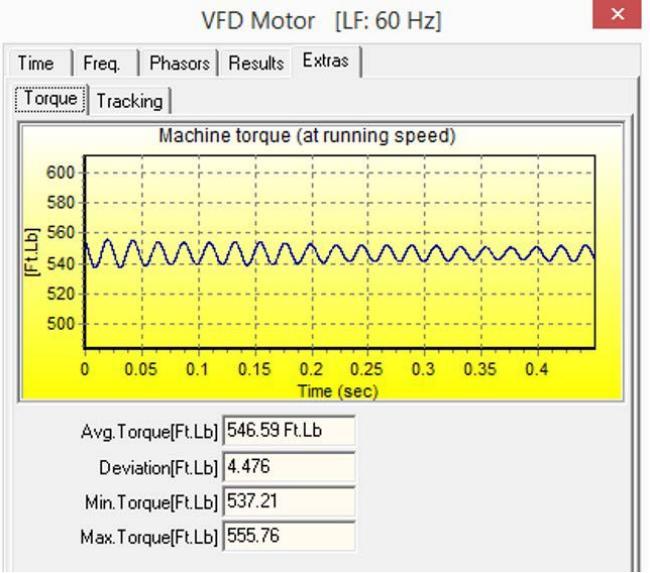
Figure 10: Torque Ripple of Motor on VFD

Once the fault was identified, additional work was performed to determine if the existing torsional vibration (torque ripple) could be further reduced. This included operating the equipment across a variety of loads and operating speeds and comparing the data.

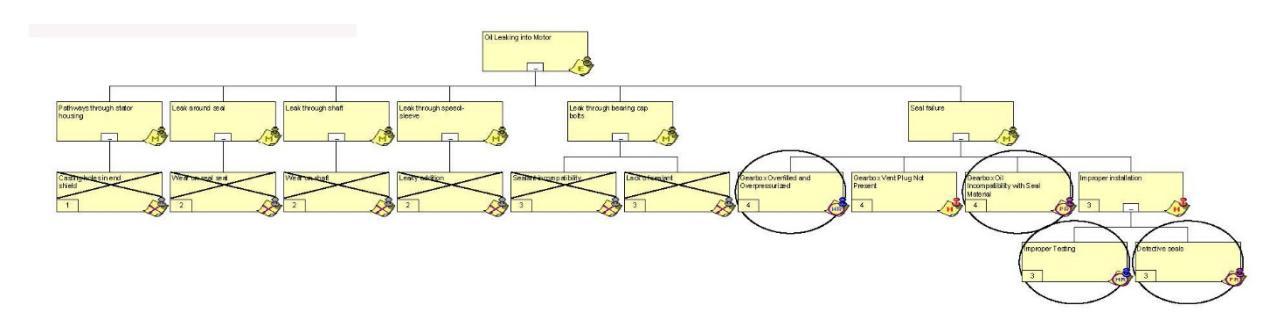
Figure 11: Failure Analysis of Stator Seal

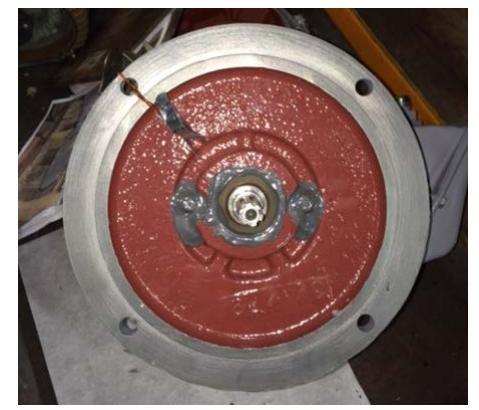
This technique calls for pursuing both obvious and not-so-obvious conditions. In this case, it was noted that the seals were sticky, malformed, and cracked. This brought about the modification required in the specification, in which a special seal is applied to the shaft to protect against the gouging of the seal into the shaft. It was found that on some of the units the seal 'rolled' because of the larger diameter, resulting in the lip facing outward and reducing the seal.

Figure 12: Motor Drive End with Seal

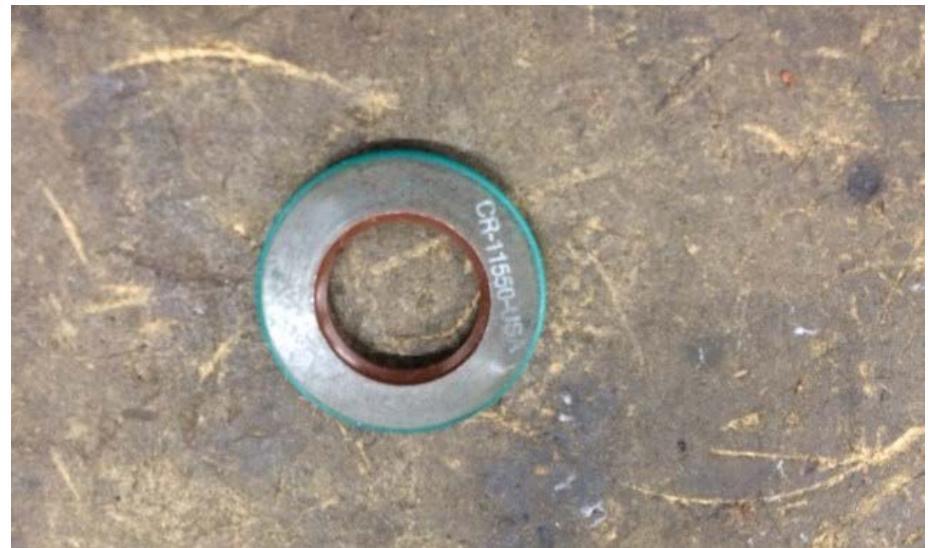
A simple question was asked, partially based upon the 'stickiness' of the Viton® seal material that had been specified. The oil was Mobil SHC 626, which was then checked against the materials chart. Viton had been selected because it is generally resistant to most materials and a broad temperature range. Upon evaluation of the material compatibility chart, it was found that most Buna[®] and Viton materials were specifically NOT compatible with the oil. In fact, there were only a handful of materials that could be used.

Figure 13: Failed Seal

The result was that a material was selected that could be applied as a seal and gasket. Additionally, shaft repair changes were implemented, including turning the shaft and applying a sleeve.

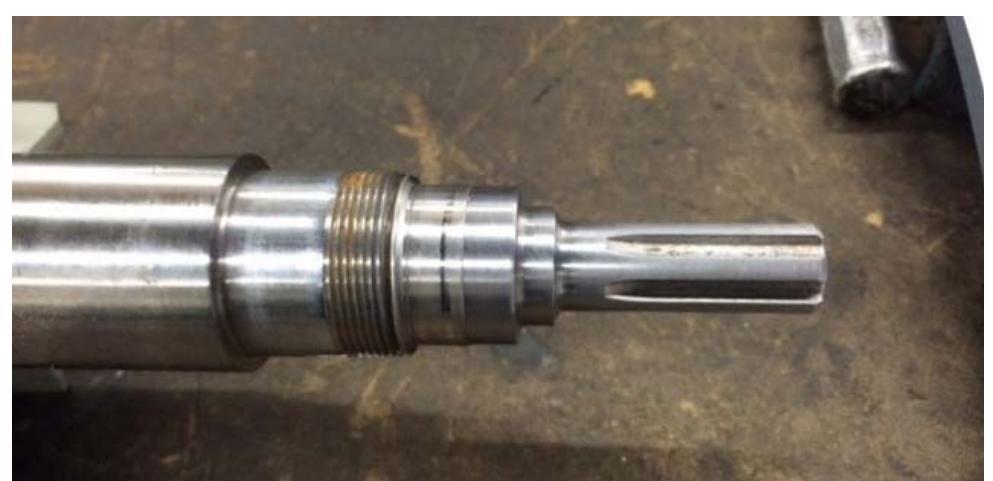
Figure 14: Shaft Seal Surface
